SUN VIZOR BULBS

BULB REMOVAL.

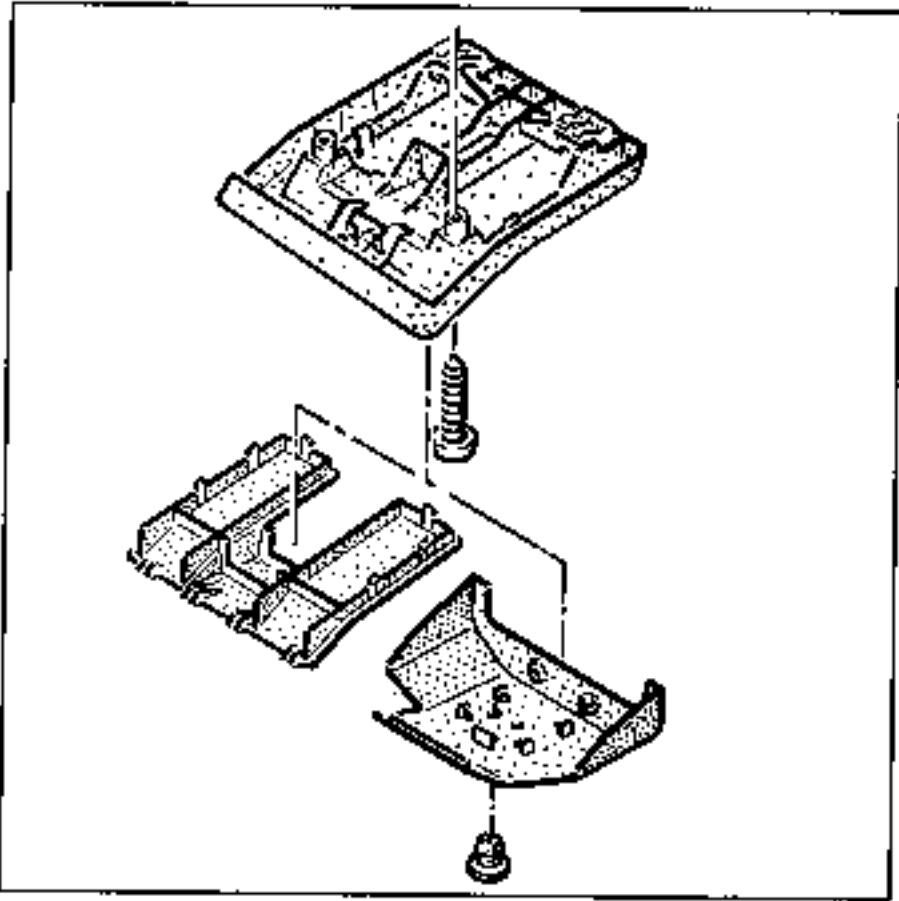
Remove the roof console.

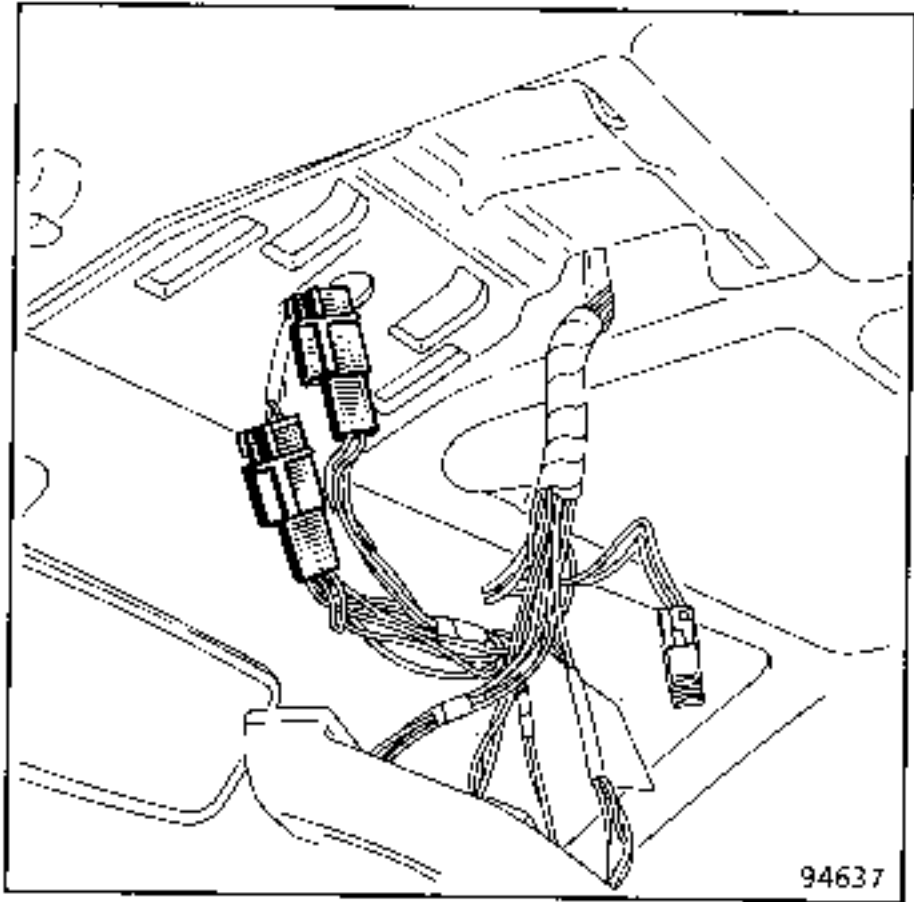
Disconnect the wiring harness from the sun vizor in question.

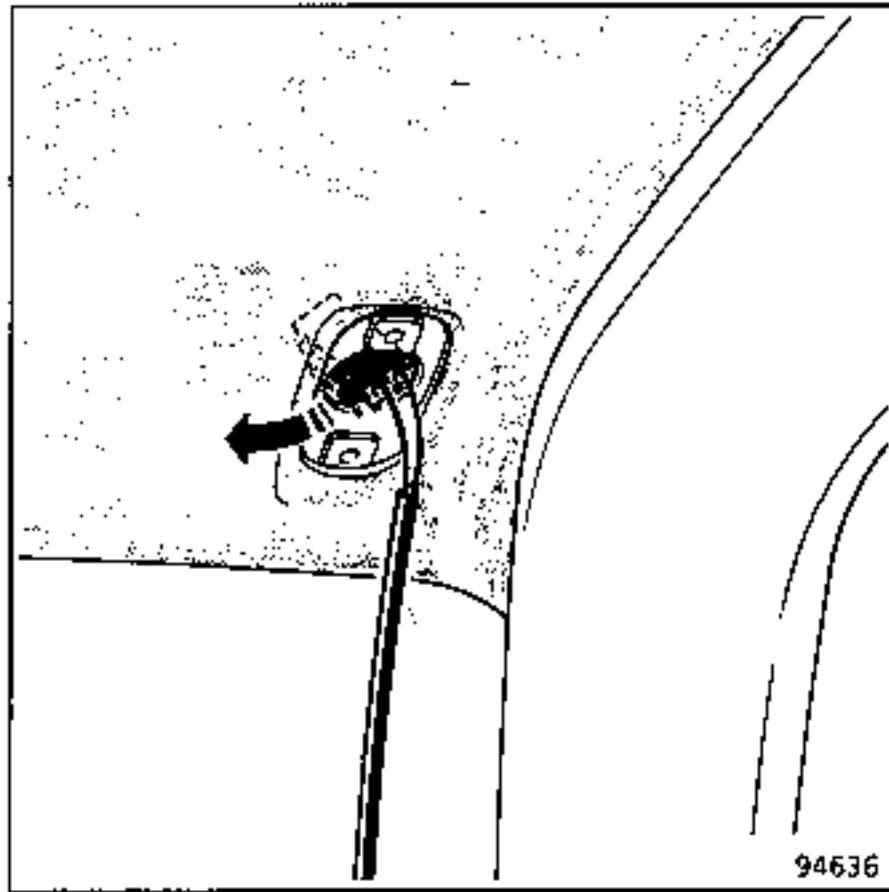
Remove the screws from the sun vizor.

Take out the connector in the position shown.

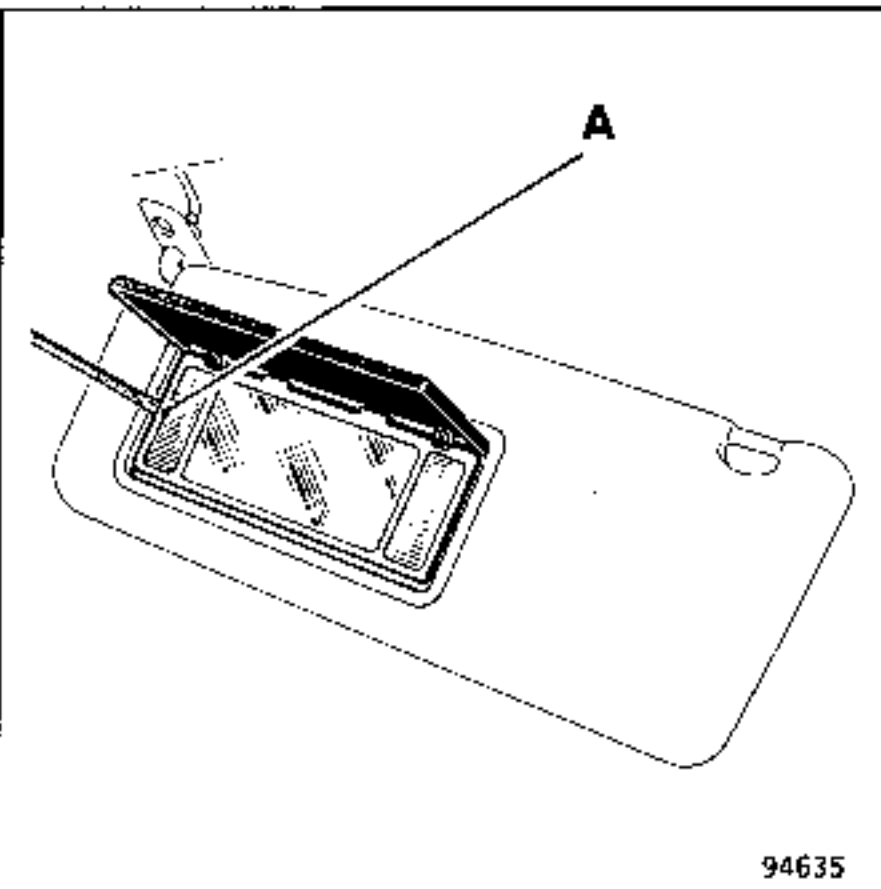
Open the courtesy mirror cover.

Unclip mirror assembly (A) at the side.

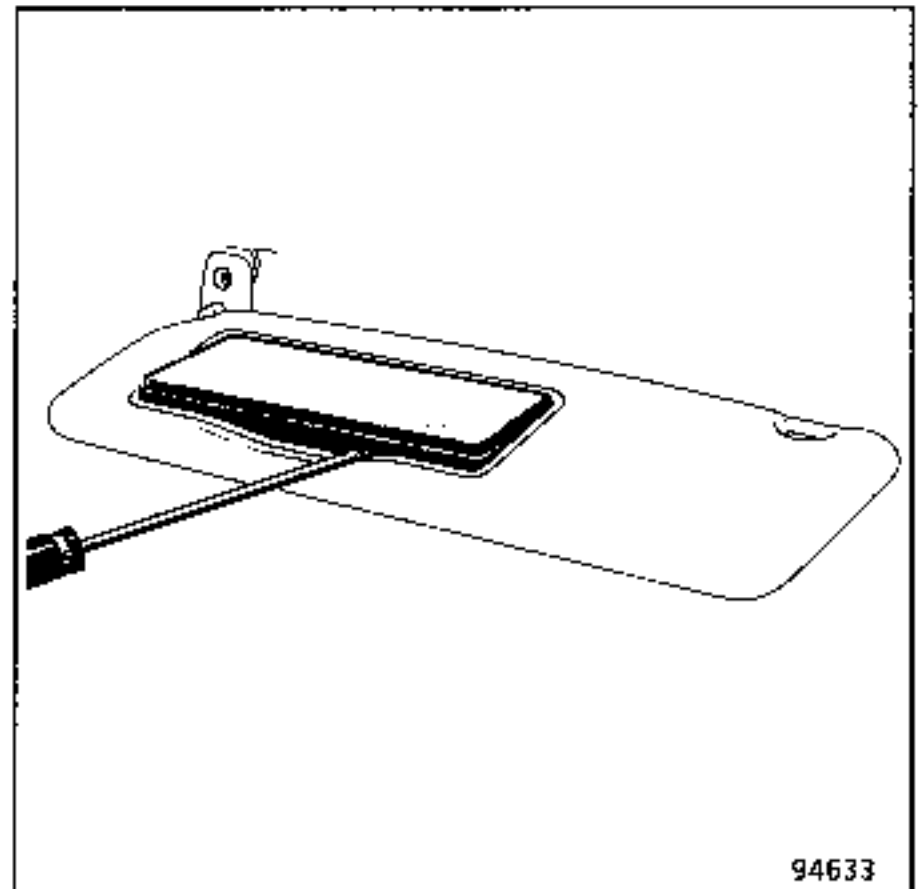
Close the mirror cover to prevent the springs falling out.

Finish by unclipping the assembly.

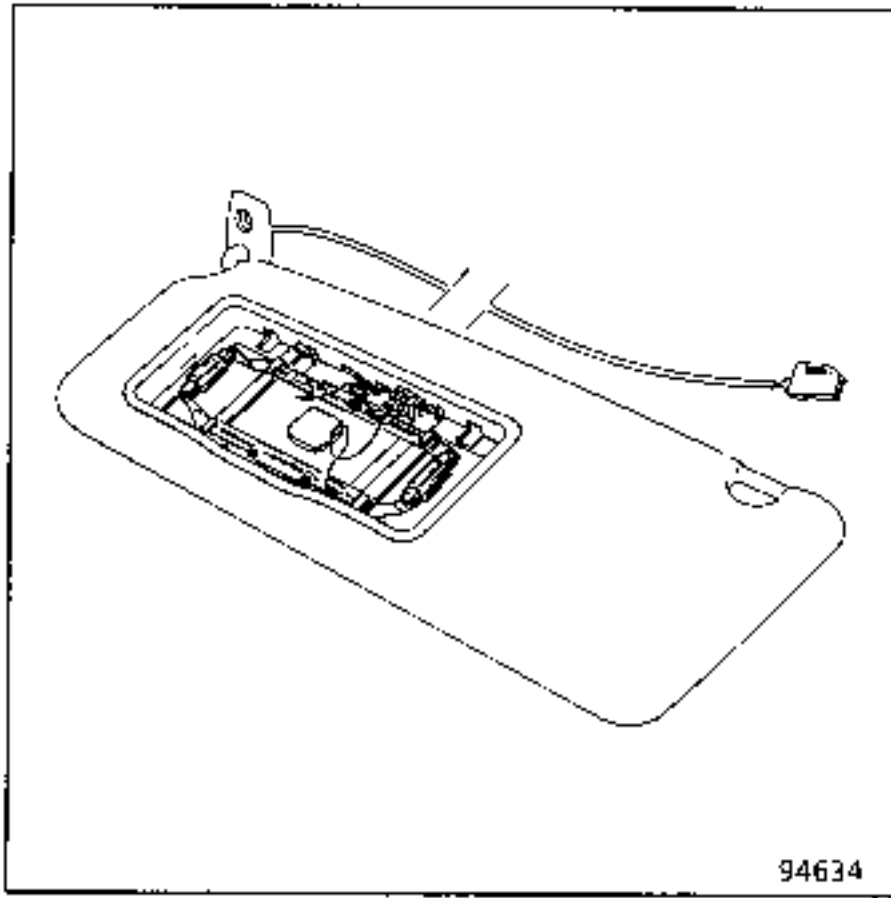
Remove the bulb or bulbs.

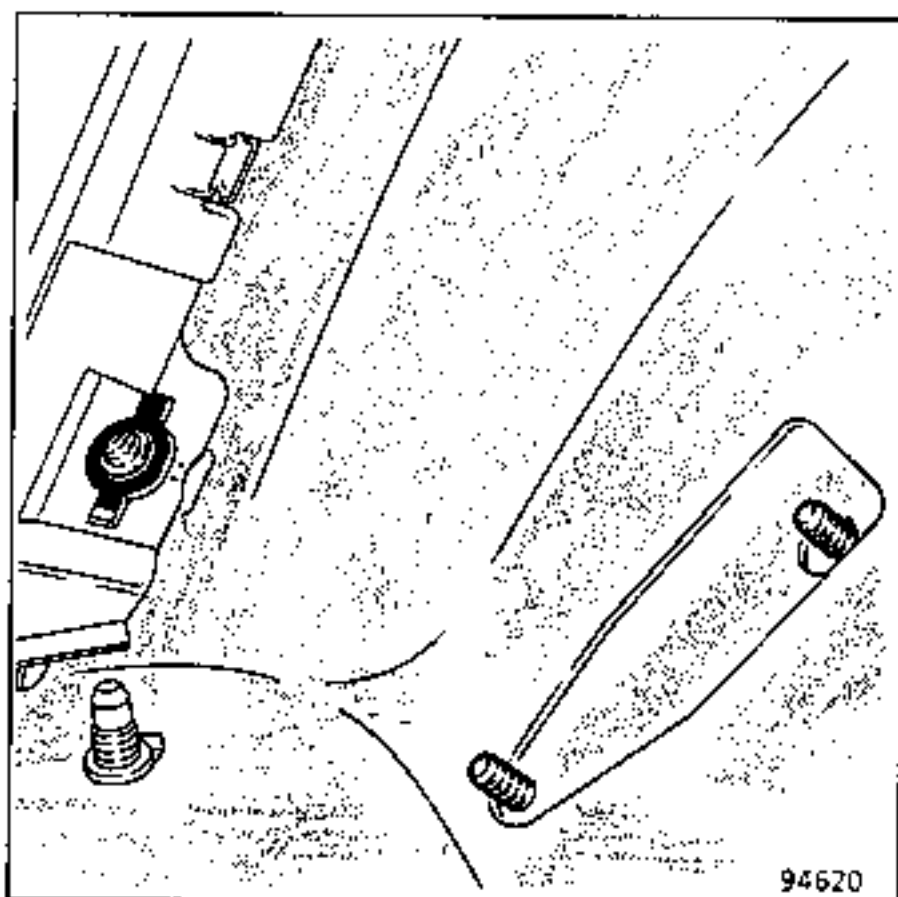
Remove the lower mounting bolt from the bodywork.

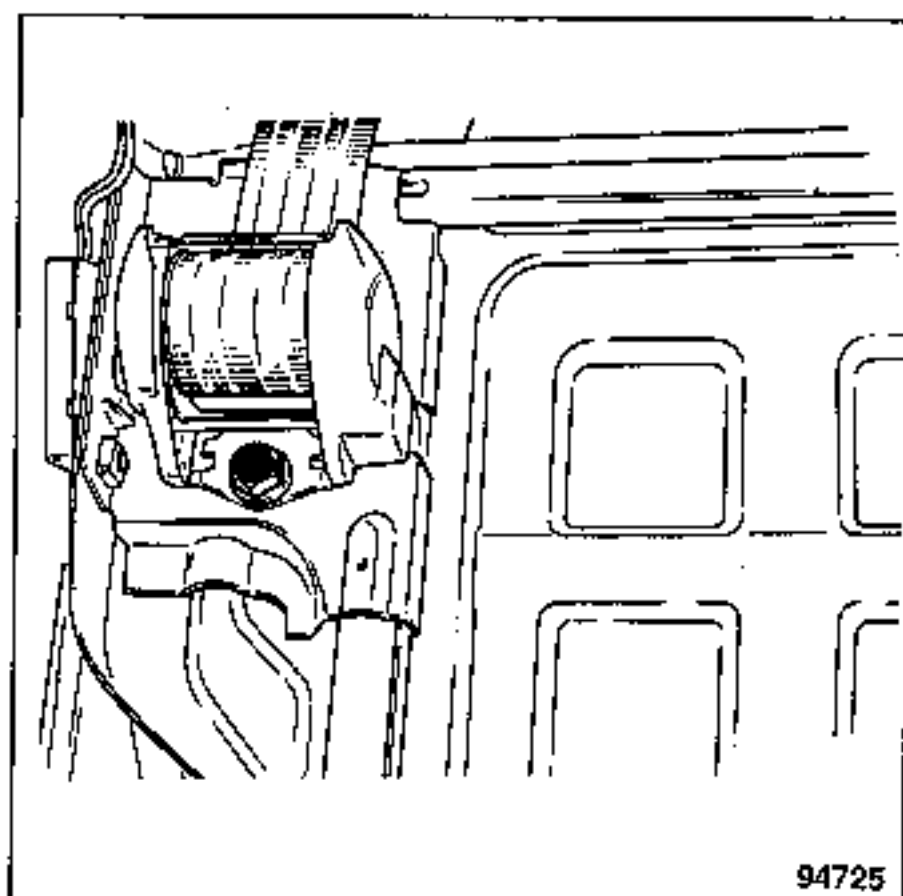
After stripping the seat back, remove the seat belt mounting.

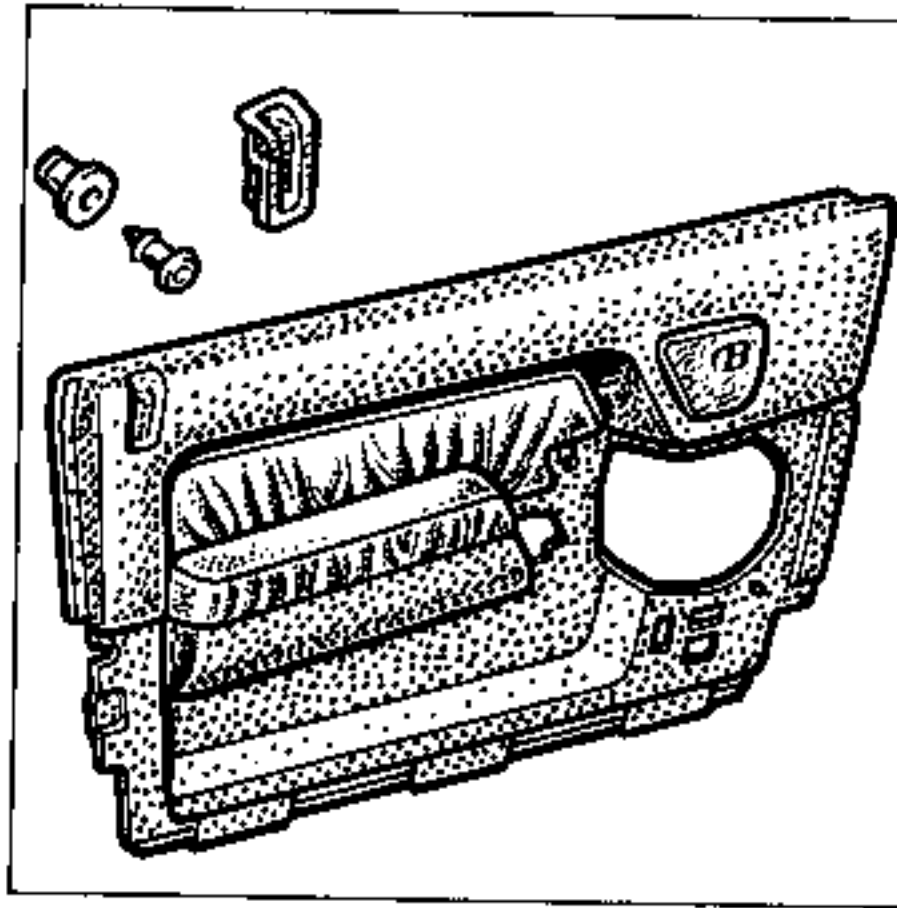
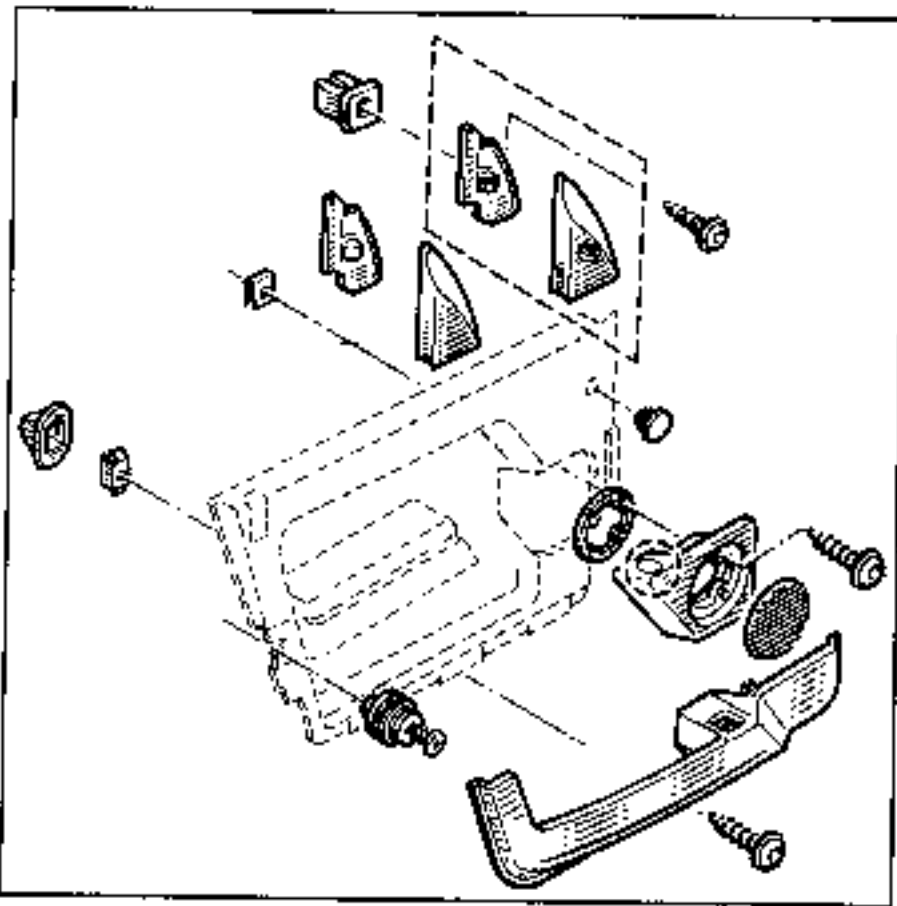
Remove:

- The rear view mirror cover.
- The grille and speaker.
- The speaker.

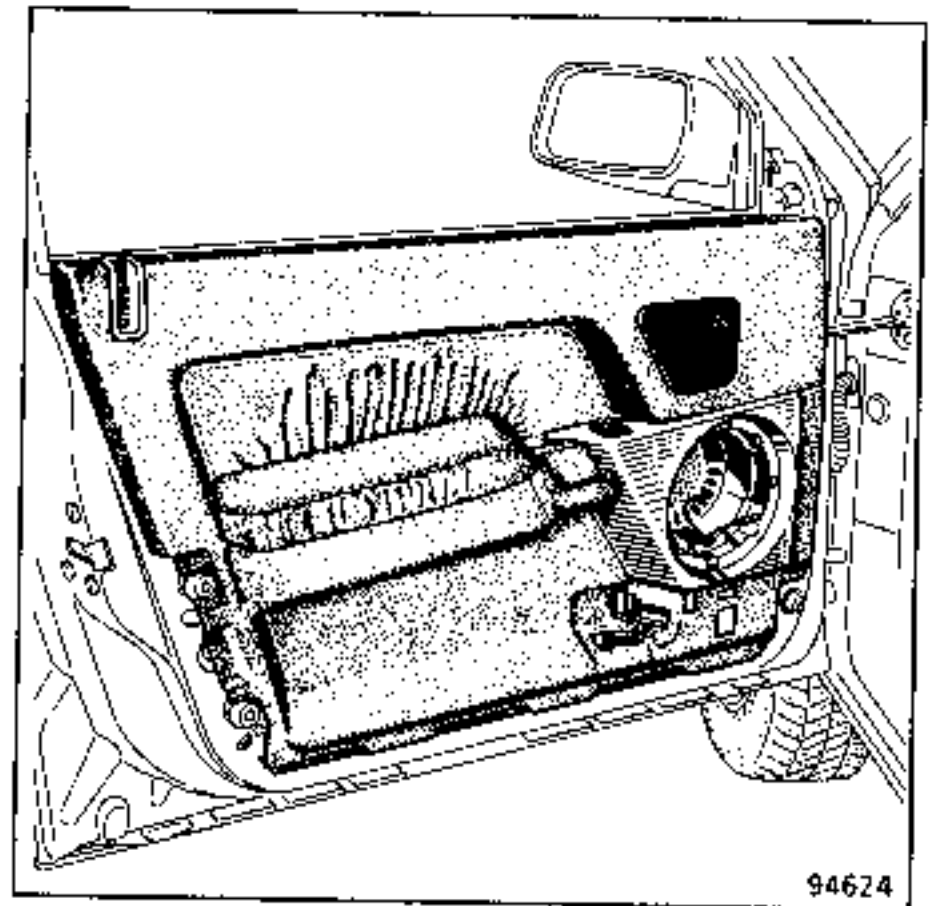
Remove:

- The window winder controls;
- The glove compartment;
- The inner handle;
- the telltale indicating whether the door is locked or unlocked.
- Unpick the trim.

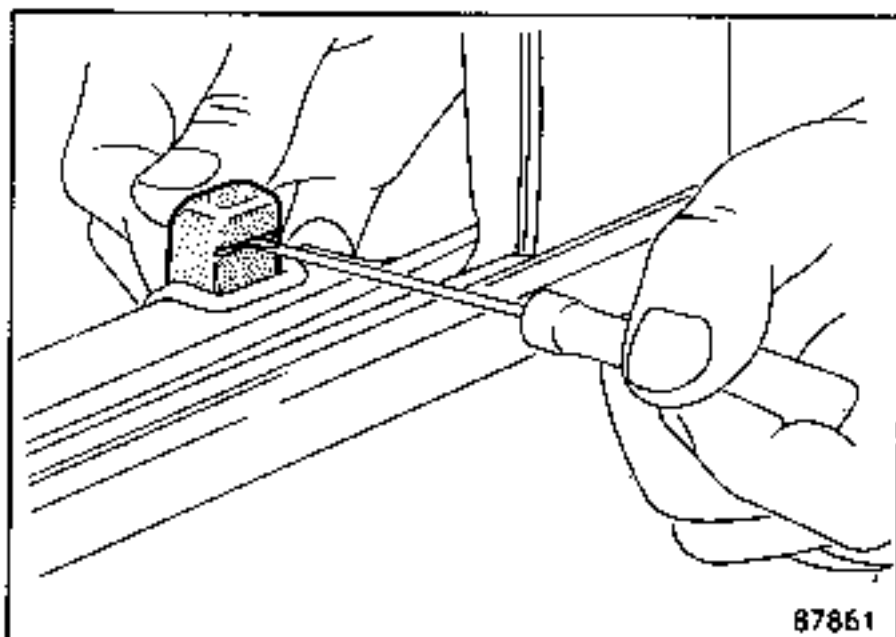
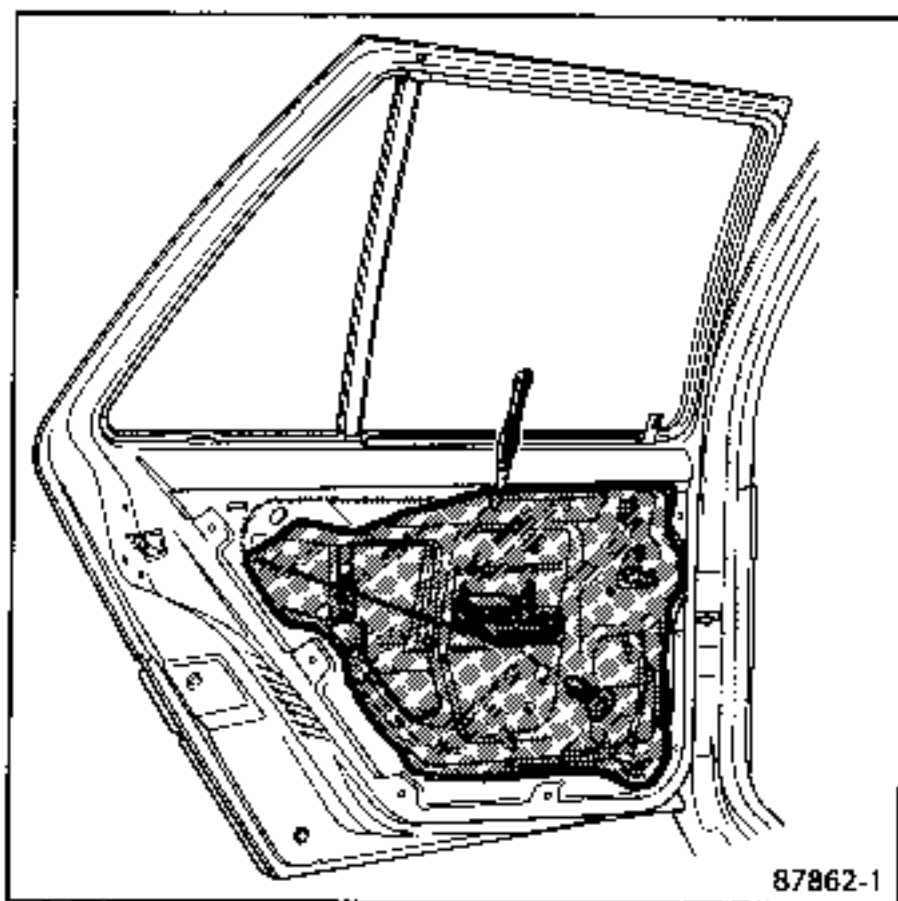
NOTE:

For reasons of quality, after any operations requiring the vinyl panel to be removed, it is essential to replace the bead of sealing mastic, before refitting the vinyl door panel.

Roll of Mastic

Part No: 77 01 423 330

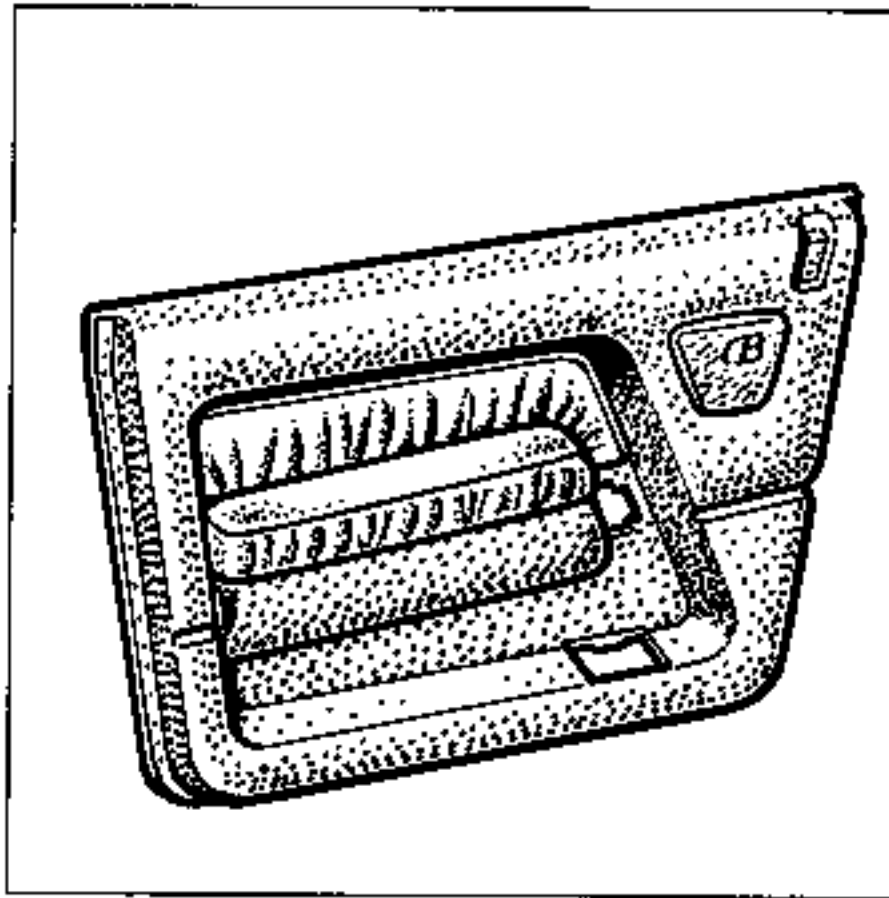
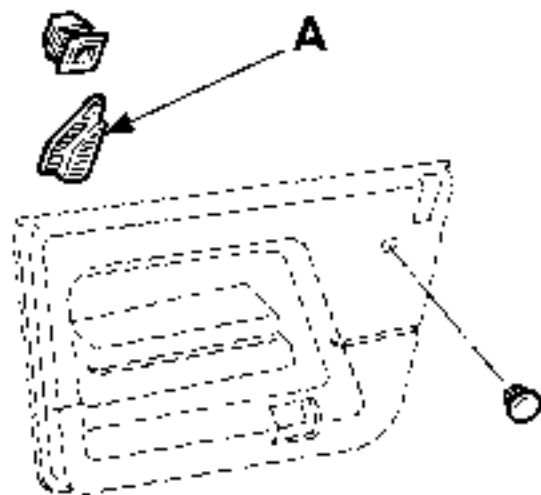
Remove :

- cover (A);
- the telltale indicating whether the door is locked or unlocked

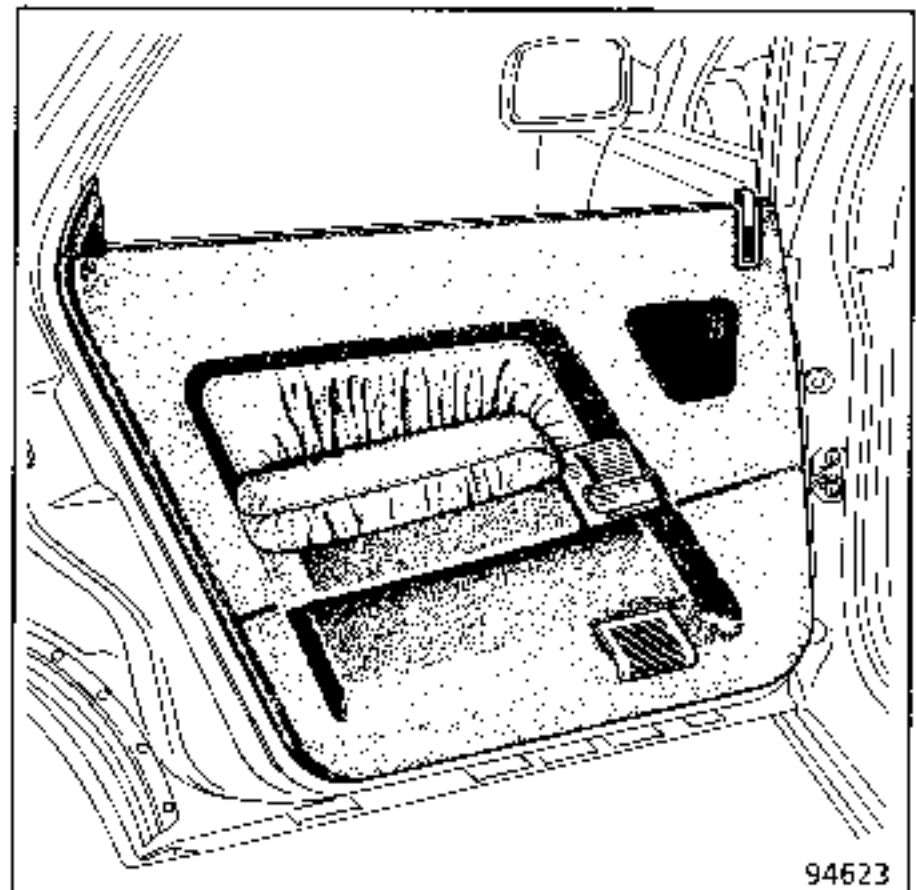
Remove :

- the inner handle,

NOTE:

For reasons of quality, after any operation requiring the vinyl panel to be removed, it is essential to replace the bead of sealing mastic before refitting this vinyl panel.

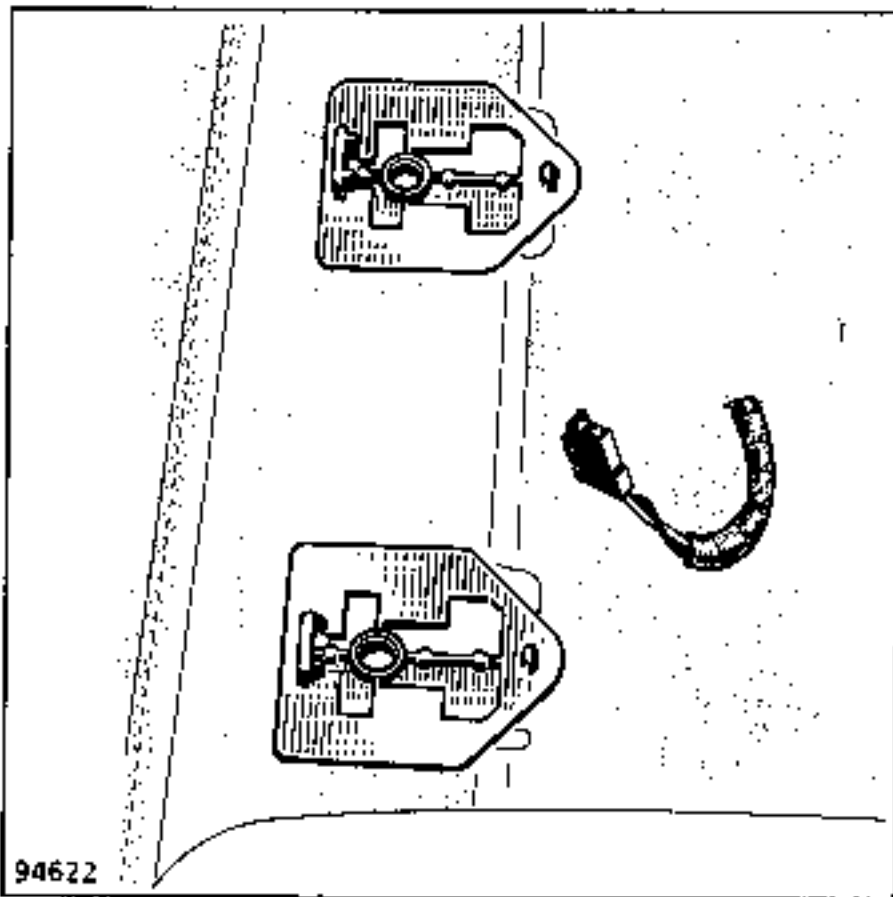
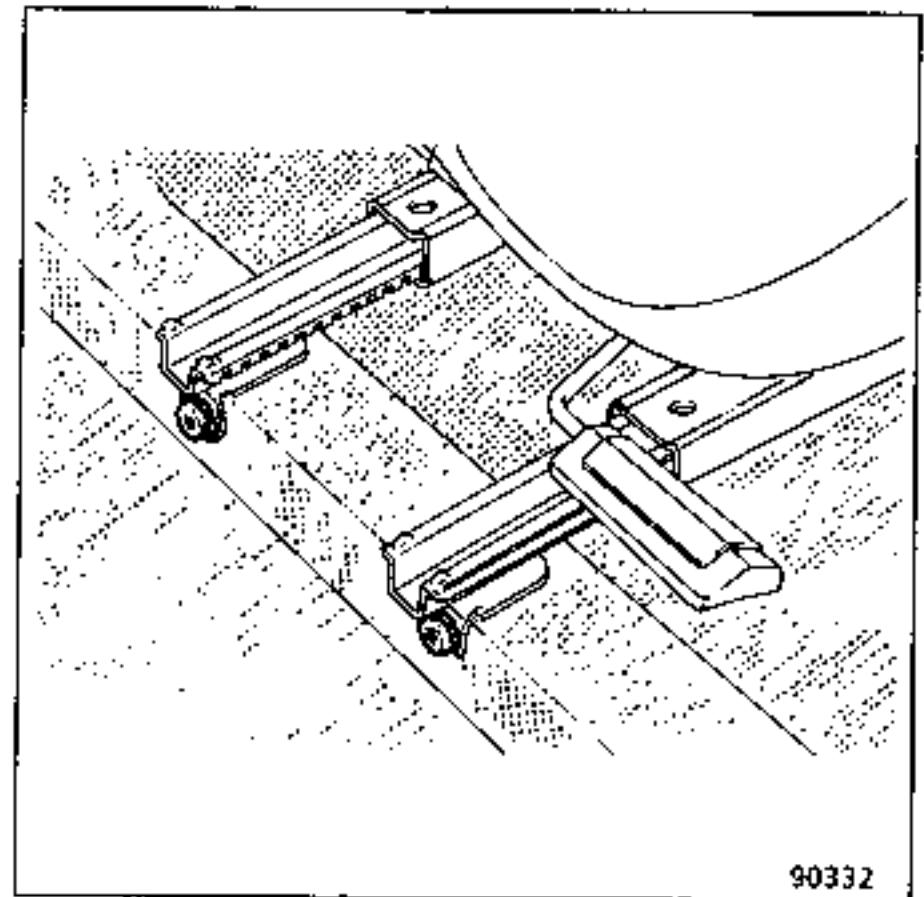
Move the seat forwards and disconnect the connector from the heated seat wiring harness.

Remove the 2 front mounting bolts.

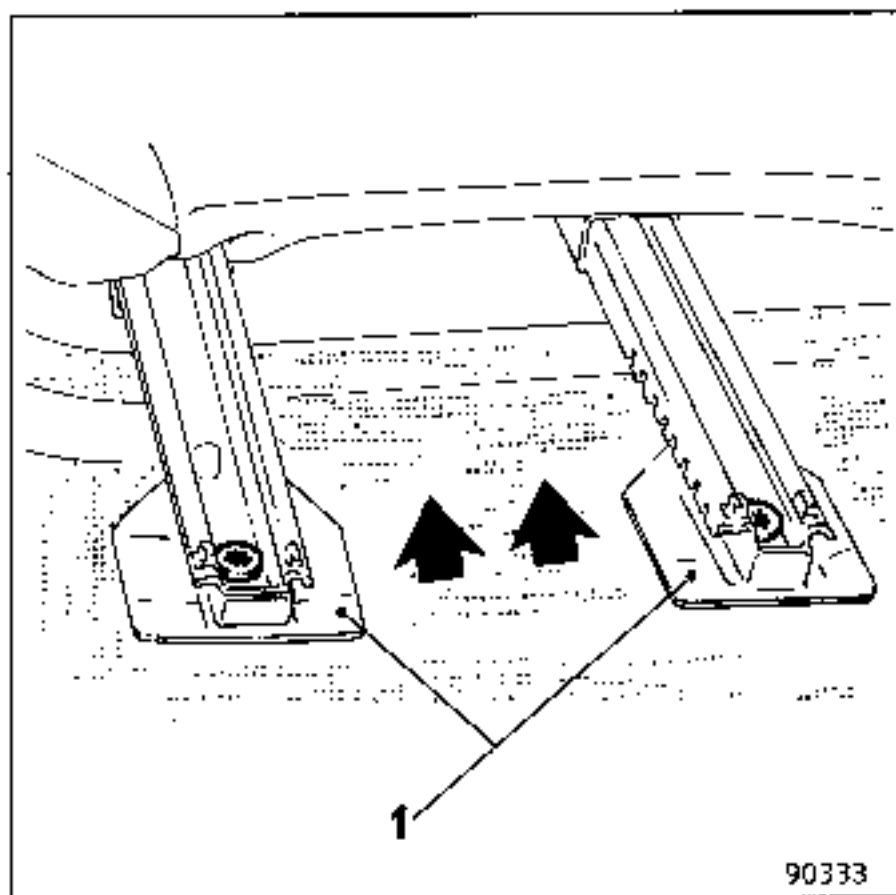
Remove the 2 rear bolts:

- the seat with the 2 anchorage plates (1), pulling it forwards.

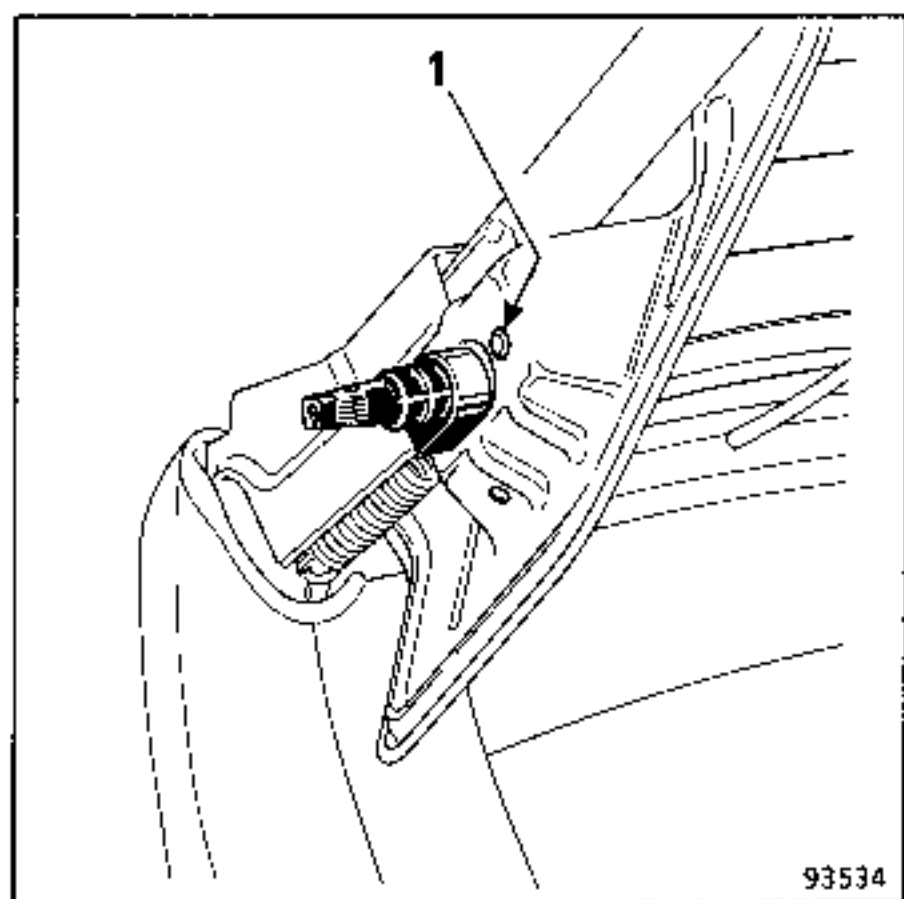
After stripping the seat back, adjust the mechanism so that it is in the slack position.

Remove rivet (1) securing the control.

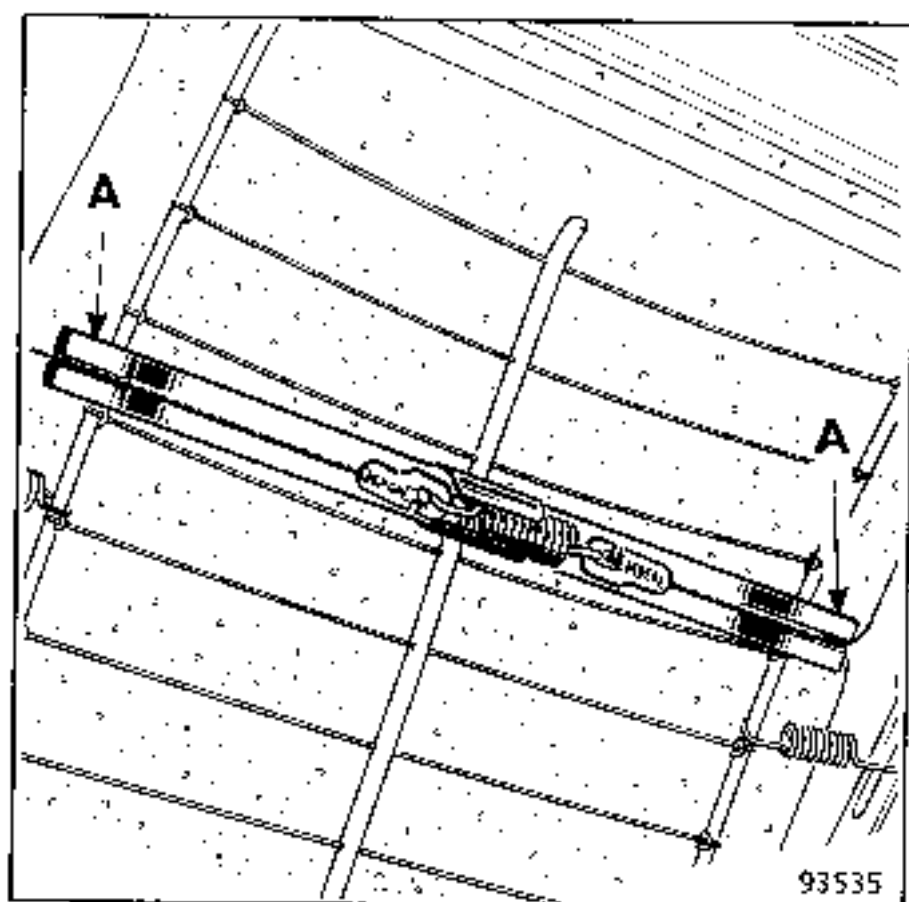
Unclip plastic guide (A).

On refitting, finish by assembling the
2 cables on the centre spring.

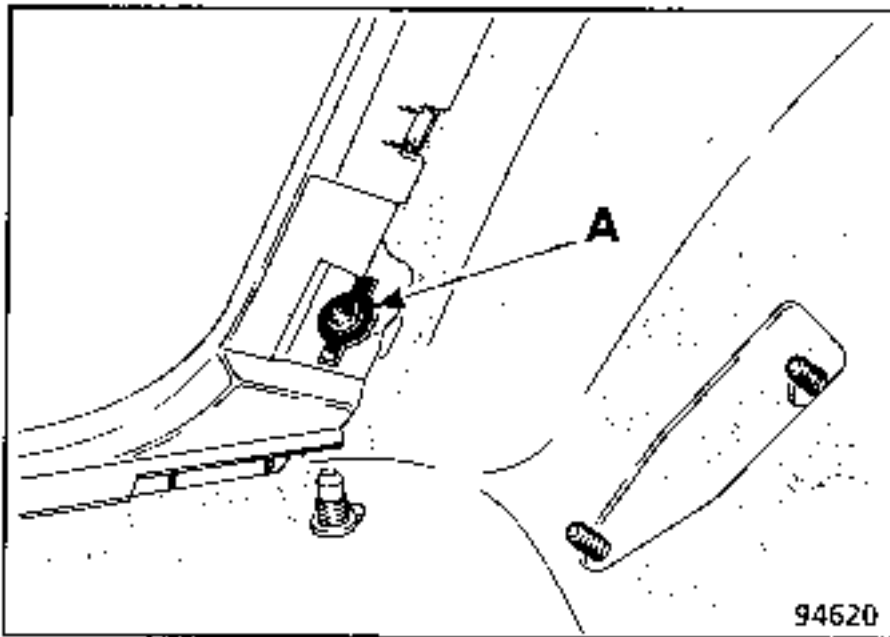
Unlock the seat locks.

Remove rear lower seat belt mounting (A).

Remove the 4 mounting nuts.

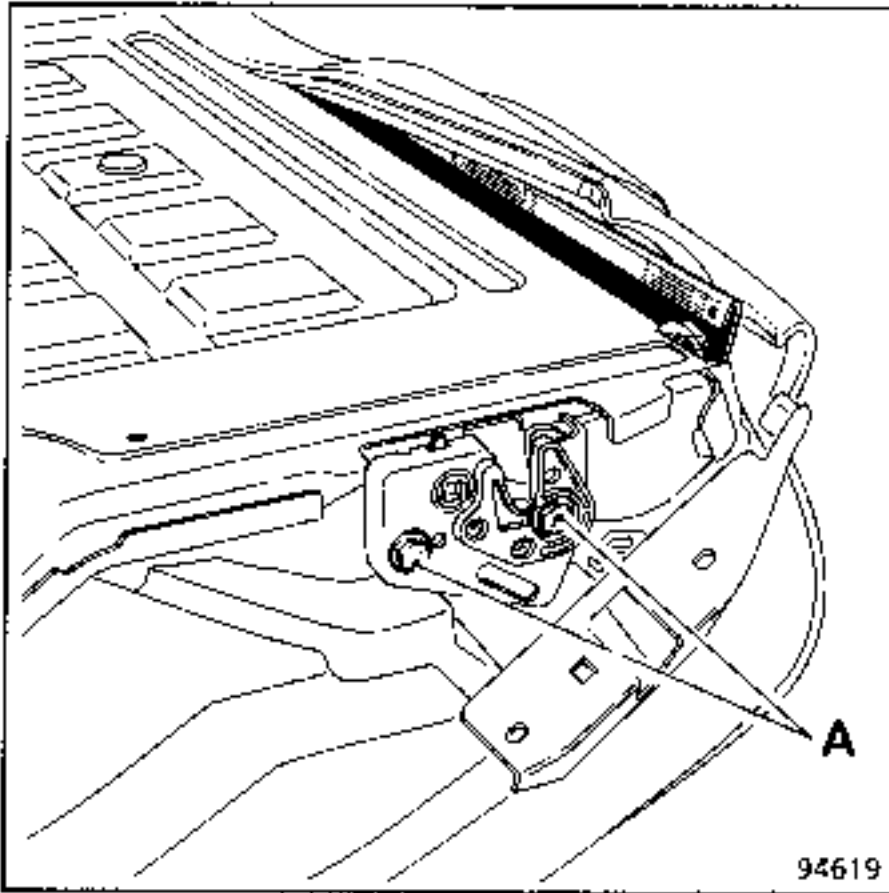
First strip the seat back in question.

Remove the lock by taking out the 2 bolts (A).

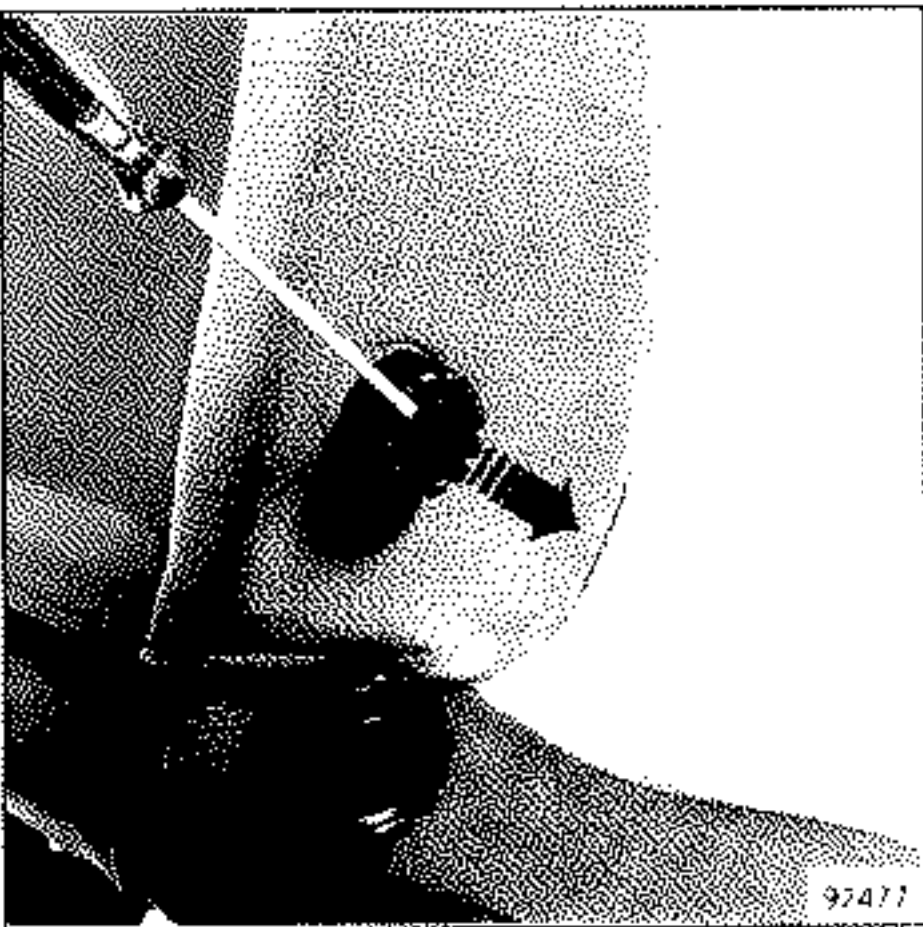
First remove the seat.

Remove the cover and handle for
the lumbar adjustment.

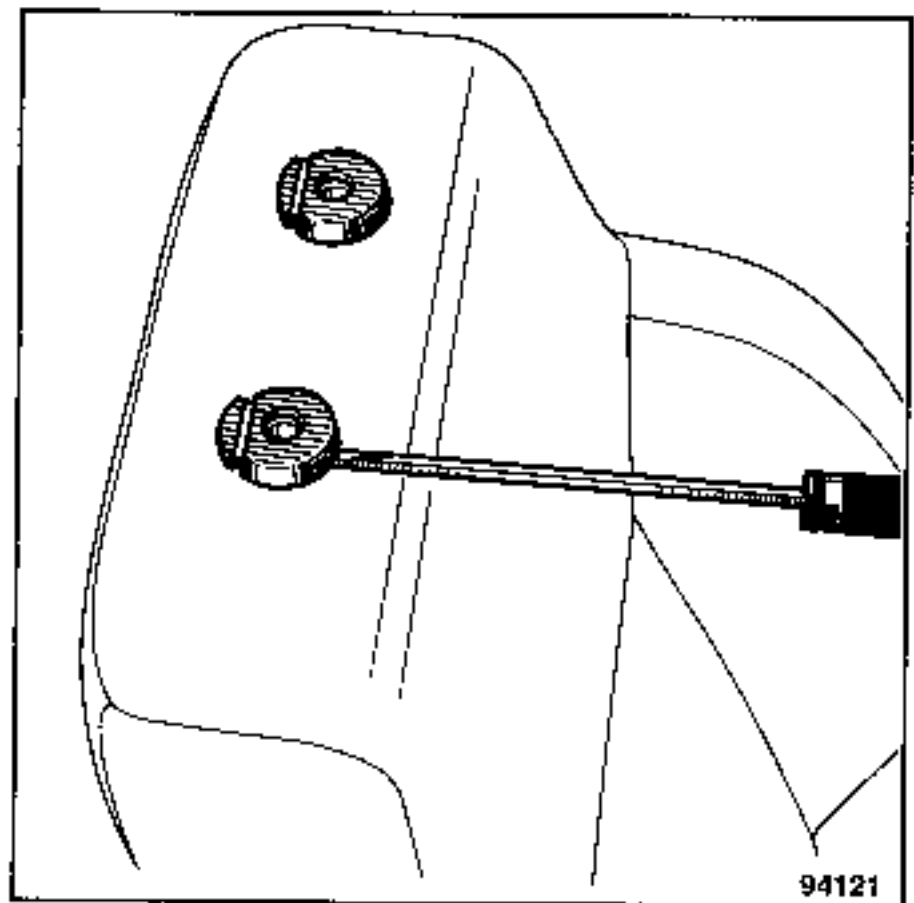
Unclip the upper parts of the head
restraint guides.

Remove the 2 hooks holding the trim
under the seat.

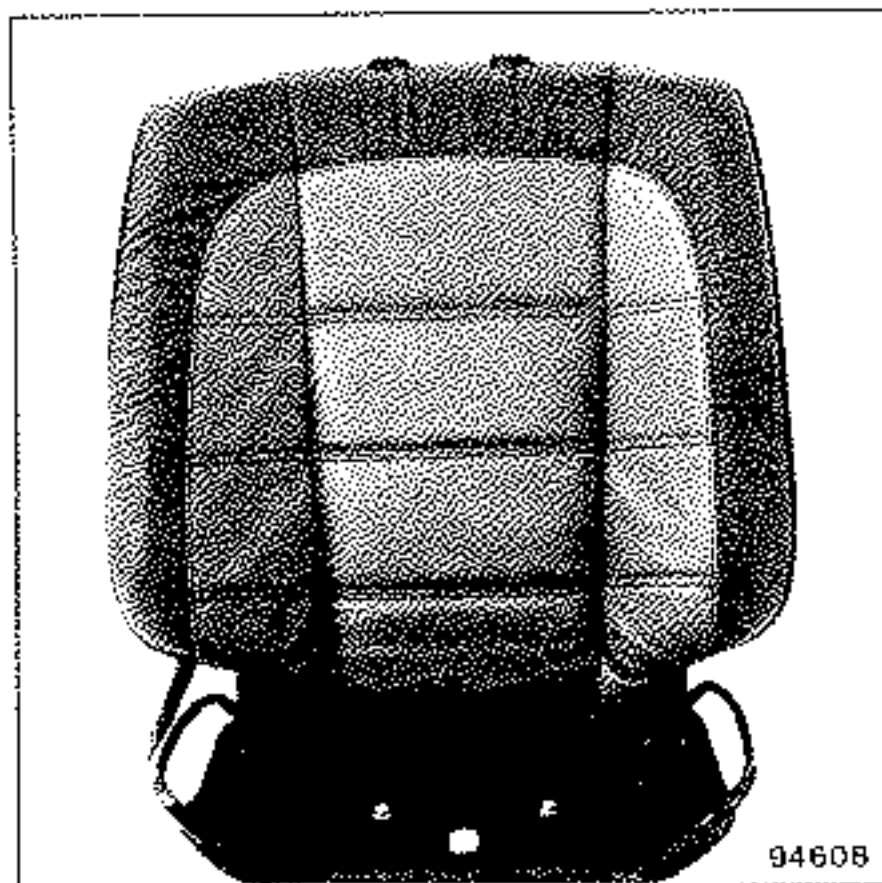
Cut out the 2 "pigs nose" clips.

NOTE:

When refitting the trim, remember to reconnect the connector for the heating system.

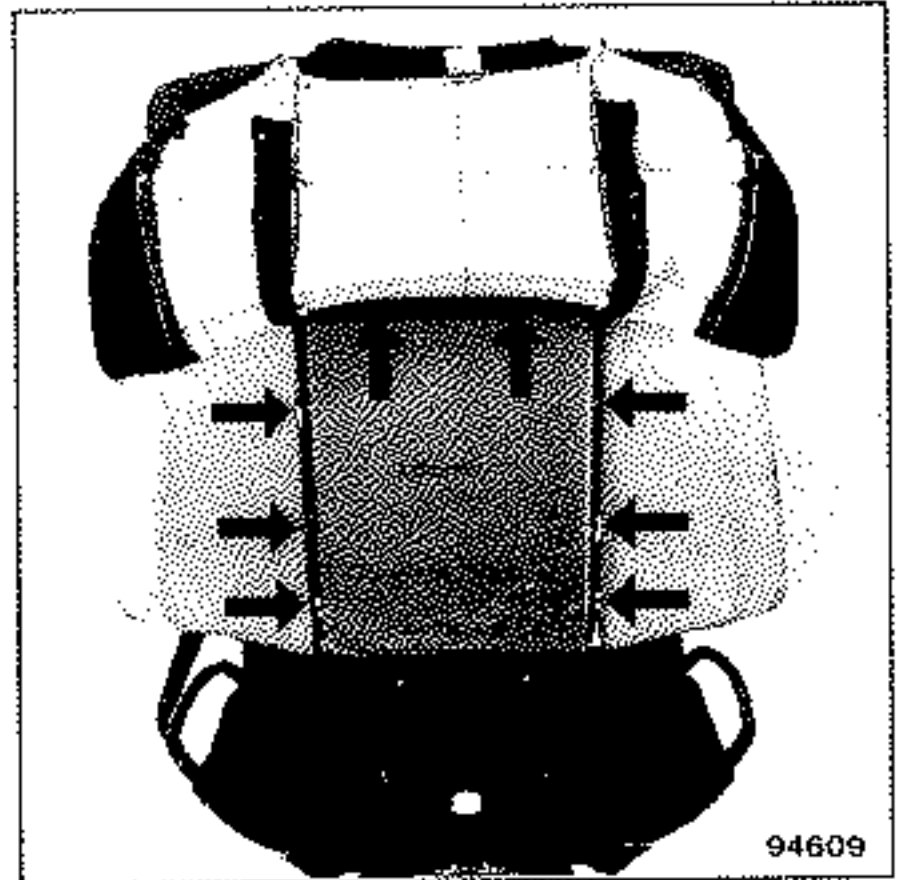
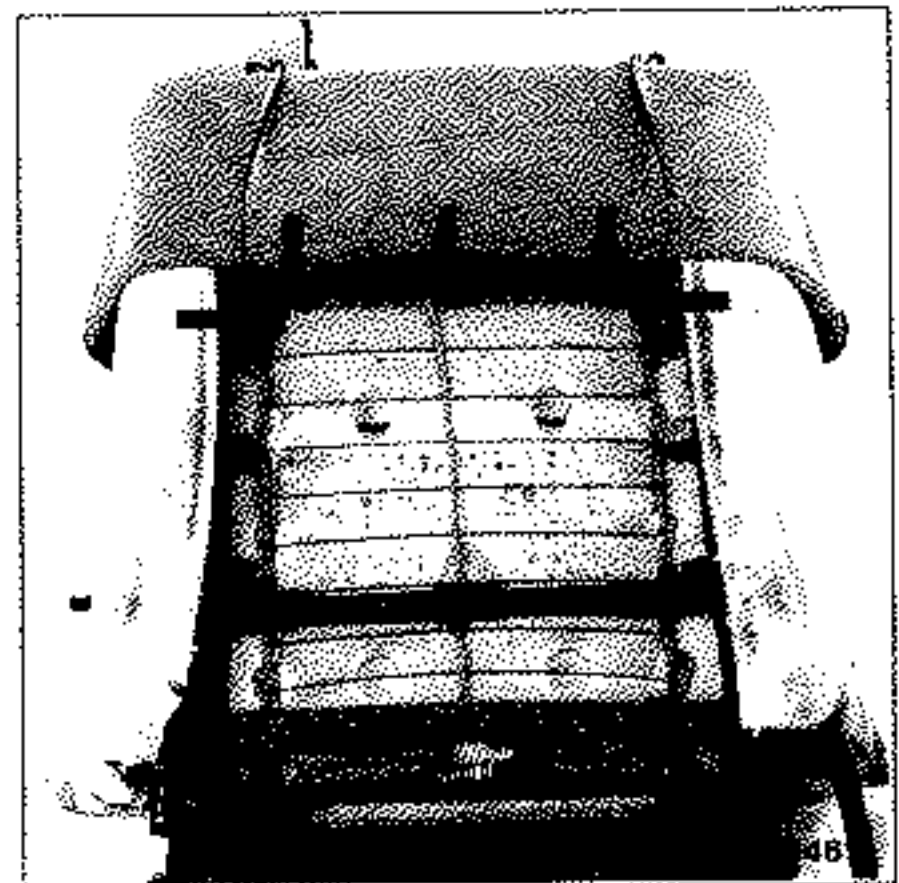
Carefully pushing up the trim, cut the "pigs nose" type clips.

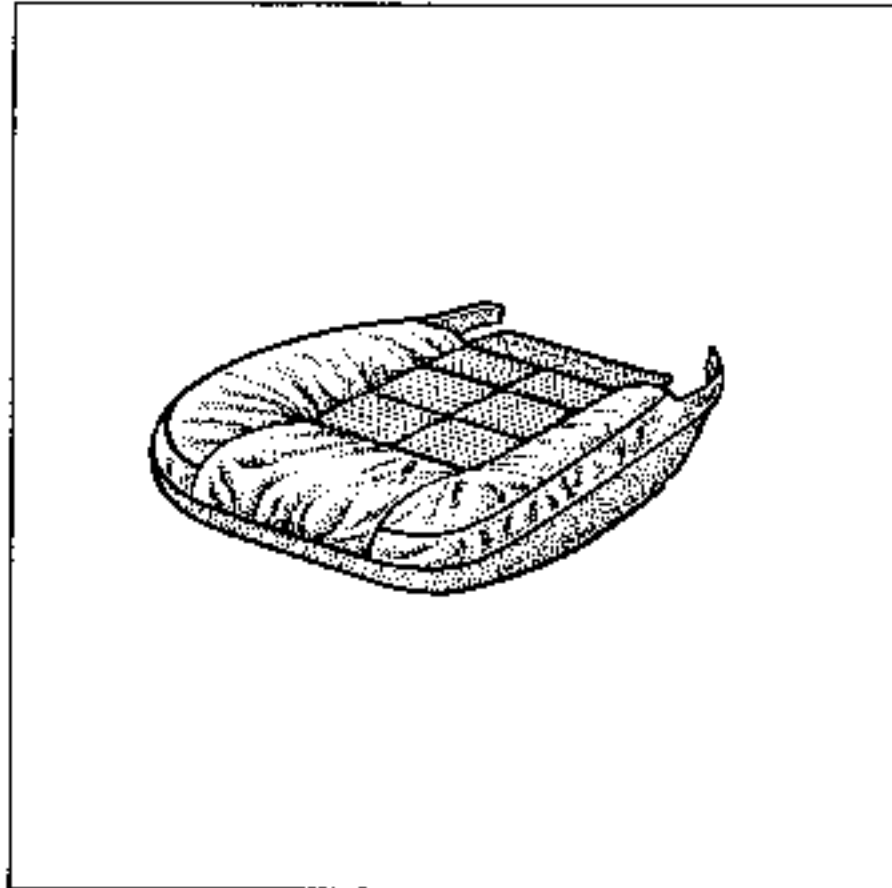
First, remove the seat.

Unfasten the 2 hooks.

Cut the 2 "pigs nose" type clips.

Cut the heating system mounting clips.

Disconnect the wiring harness from the heating system and unclip it from the set of slideways.
