SUN VIZOR BULBS

BULB REMOVAL.

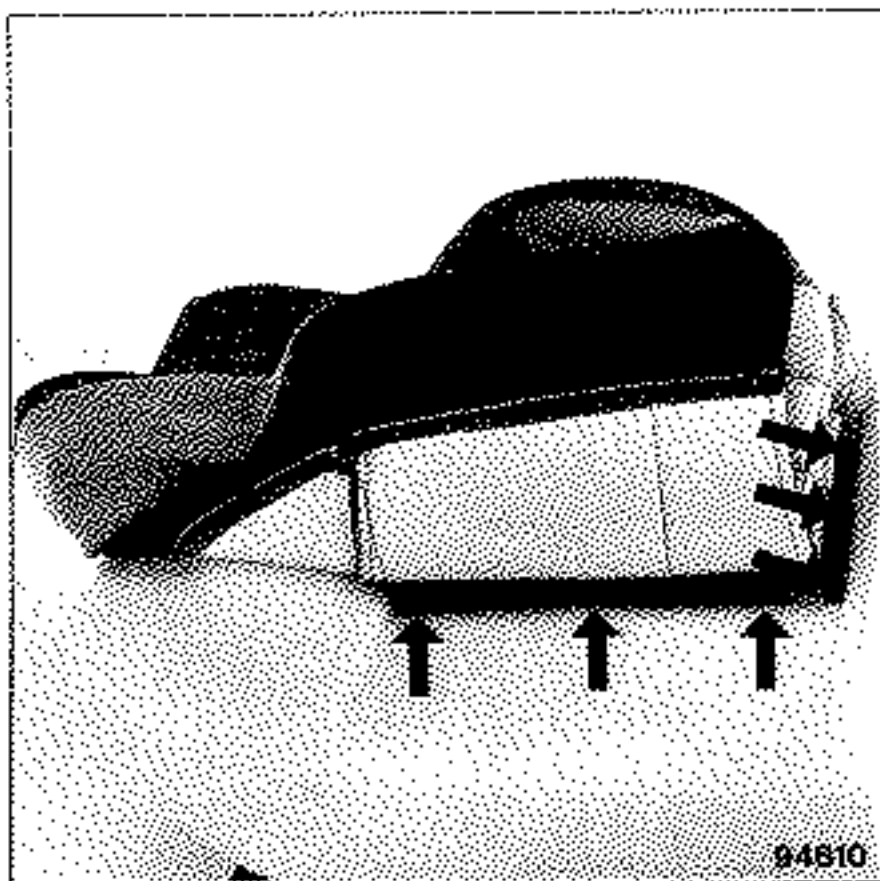
Separate the trim from the foam by cutting the "pigs nose" type clips.

NOTE:

When refitting the trim, remember to reconnect the heating system connector.

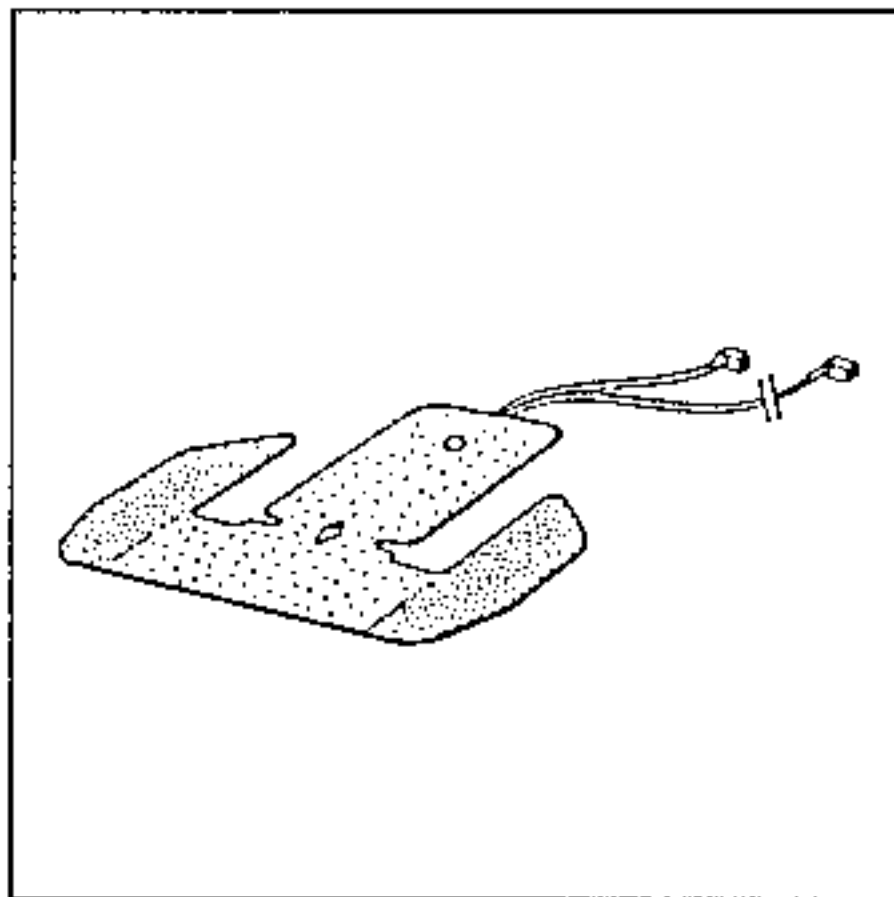
First strip the component in question.
Carefully separate the heating device
from the foam.

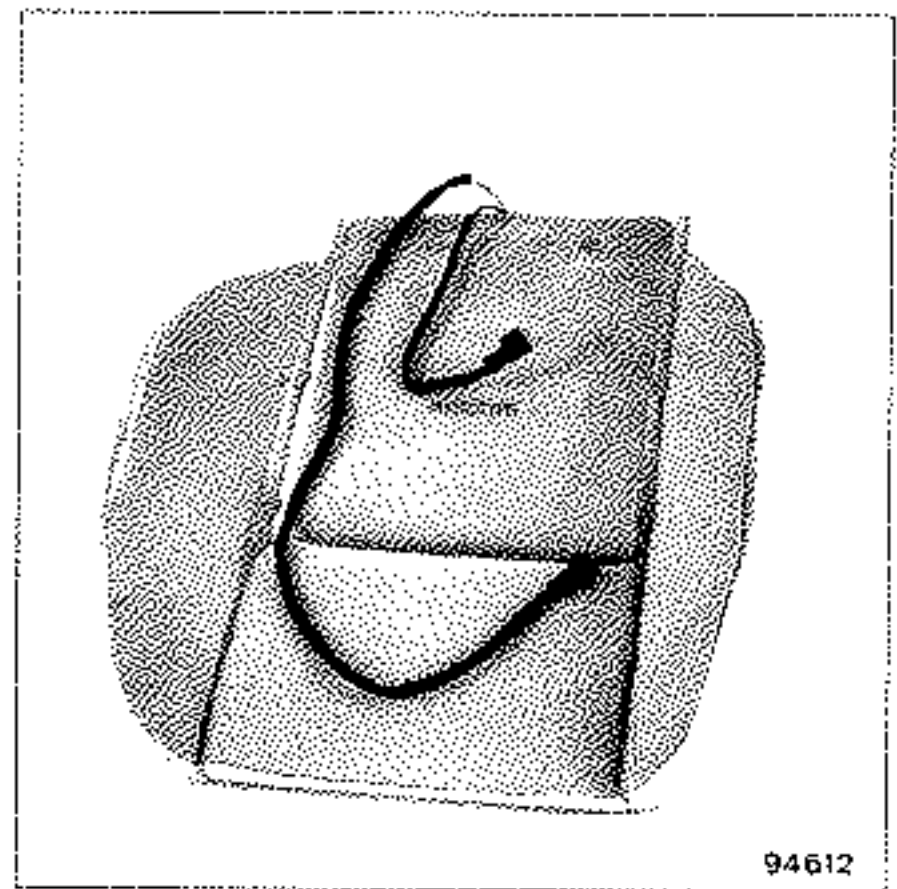
94612

On refitting, just stick the system
back in the same position.

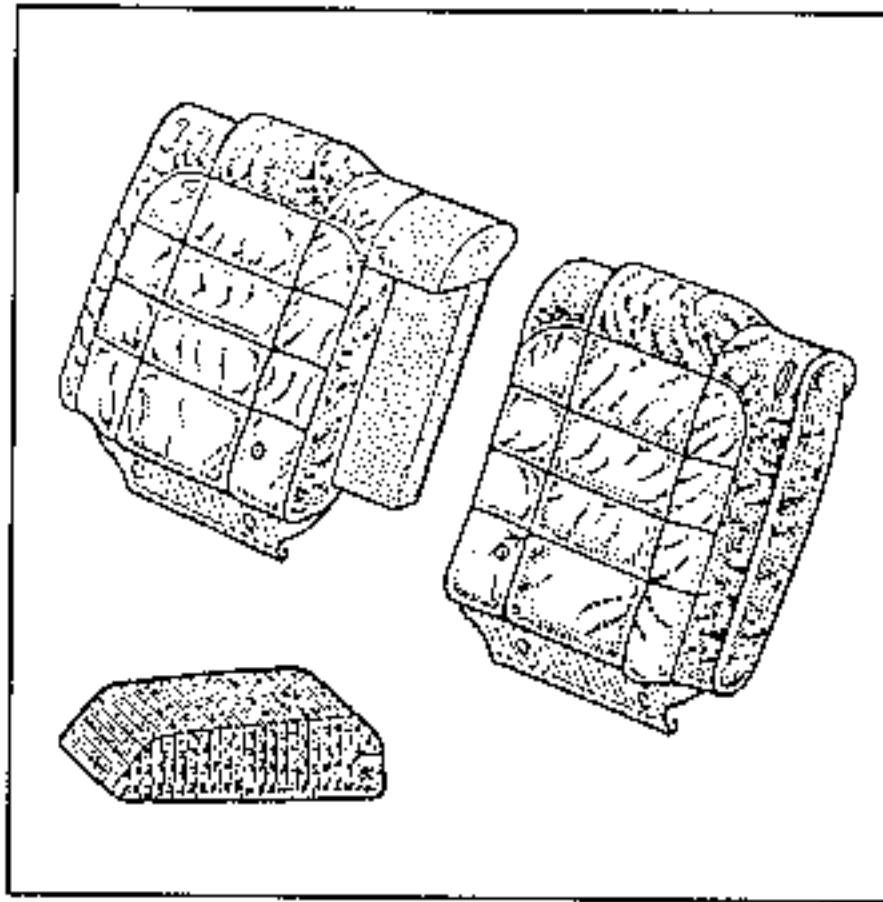
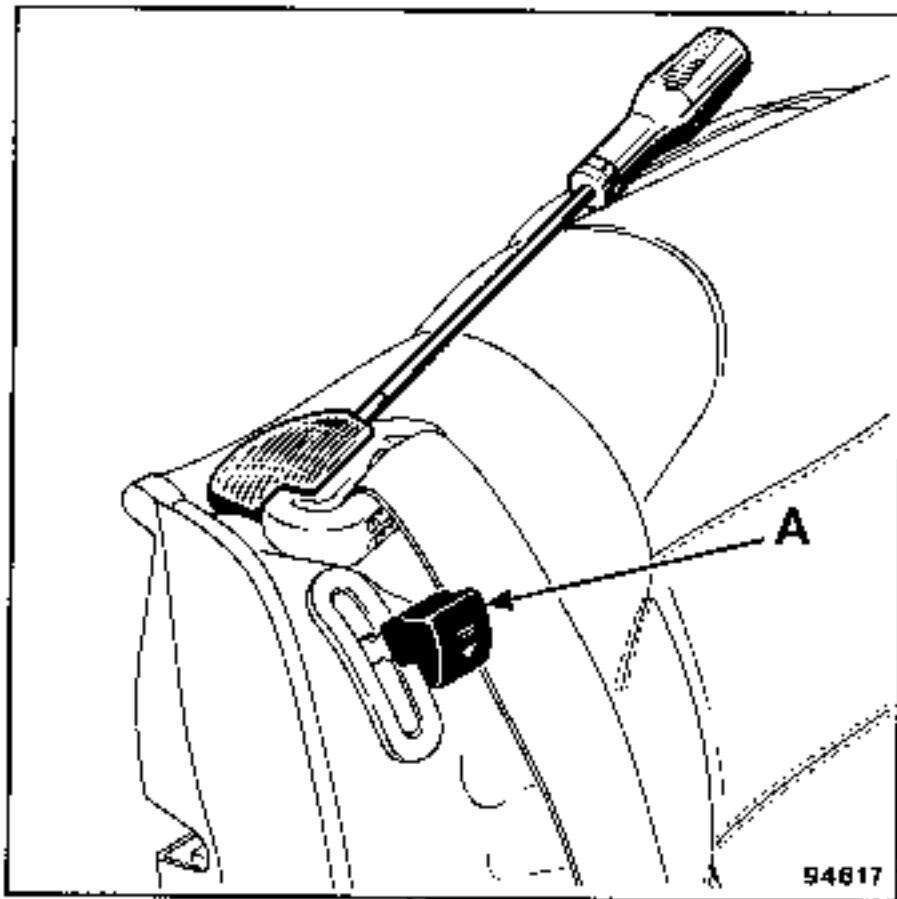
After removing the seat, remove handle (A).

Remove the upper seat belt mounting cover.

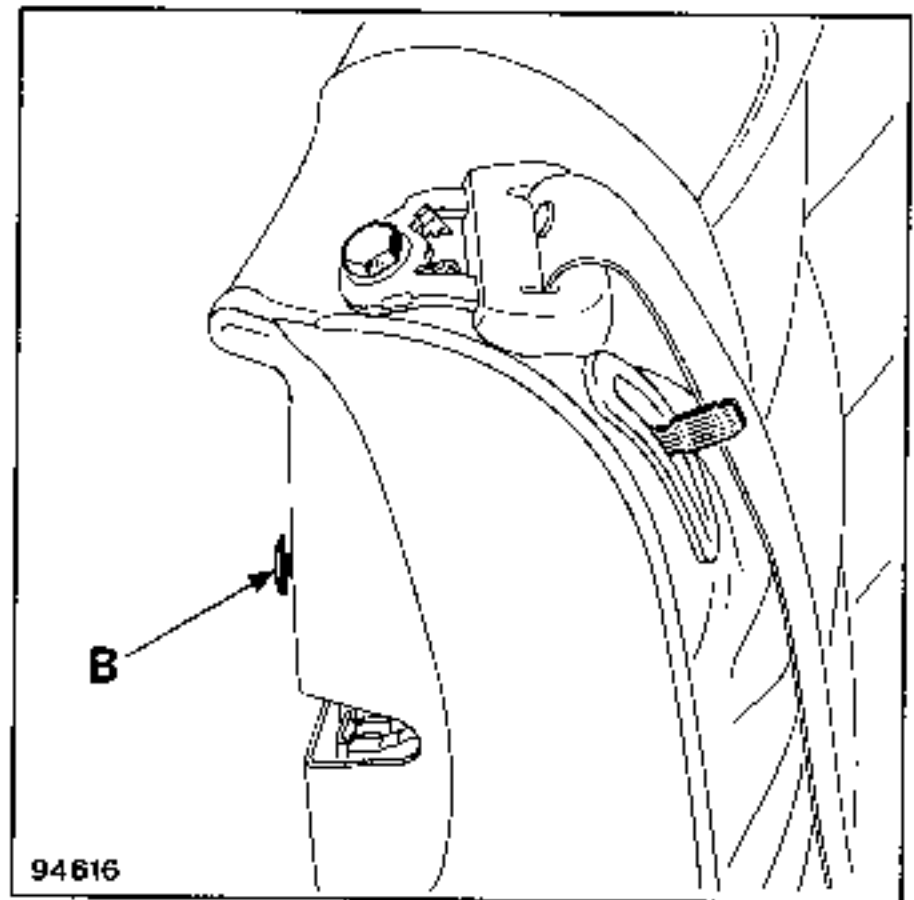
Remove clips (B) from the lock cover.

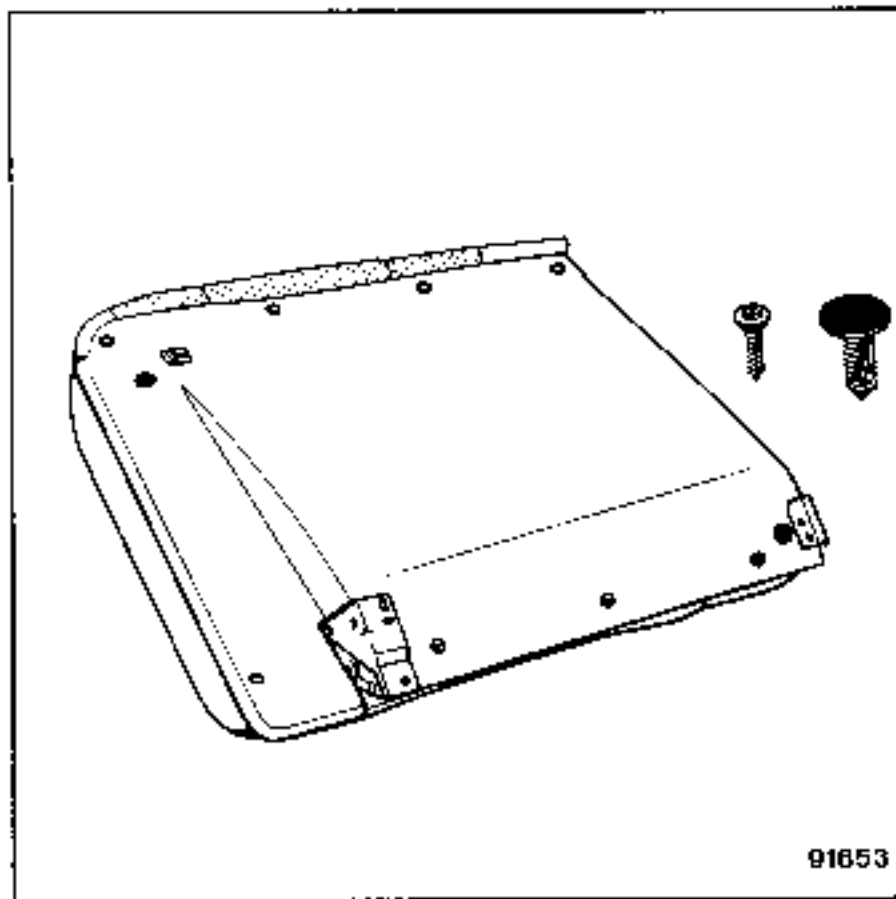
Remove the rear cover (pressure stud type clips).

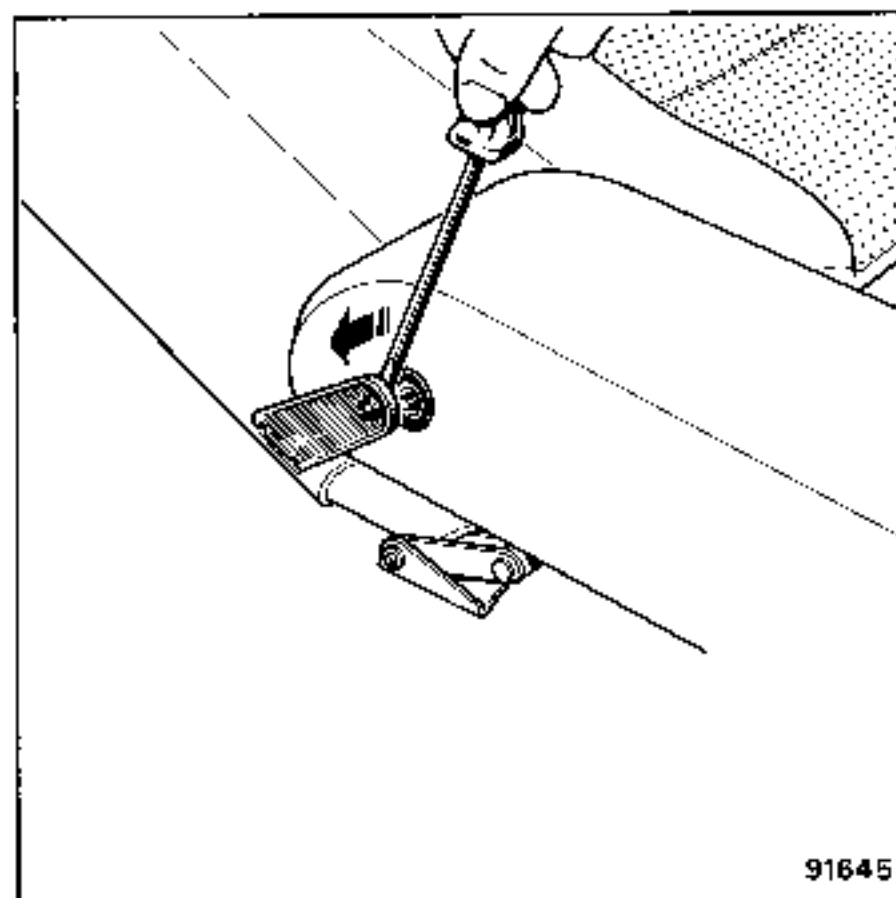
Remove the central arm rest.

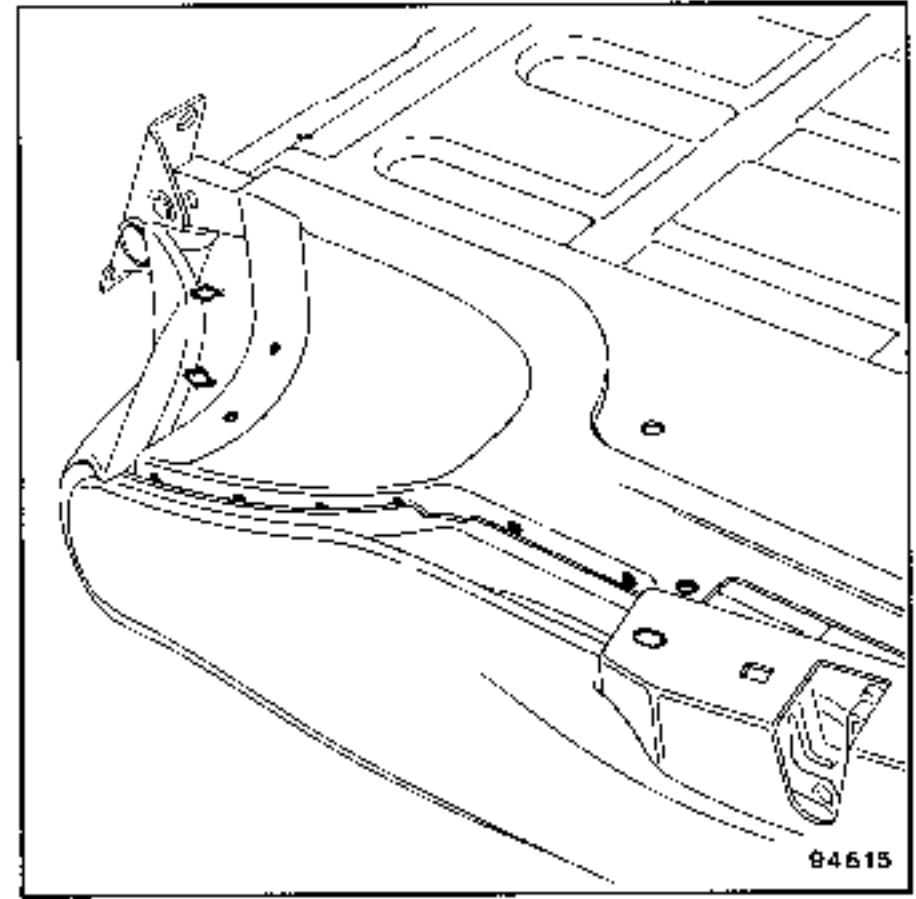
Removes edges (C) from the trim with great care.

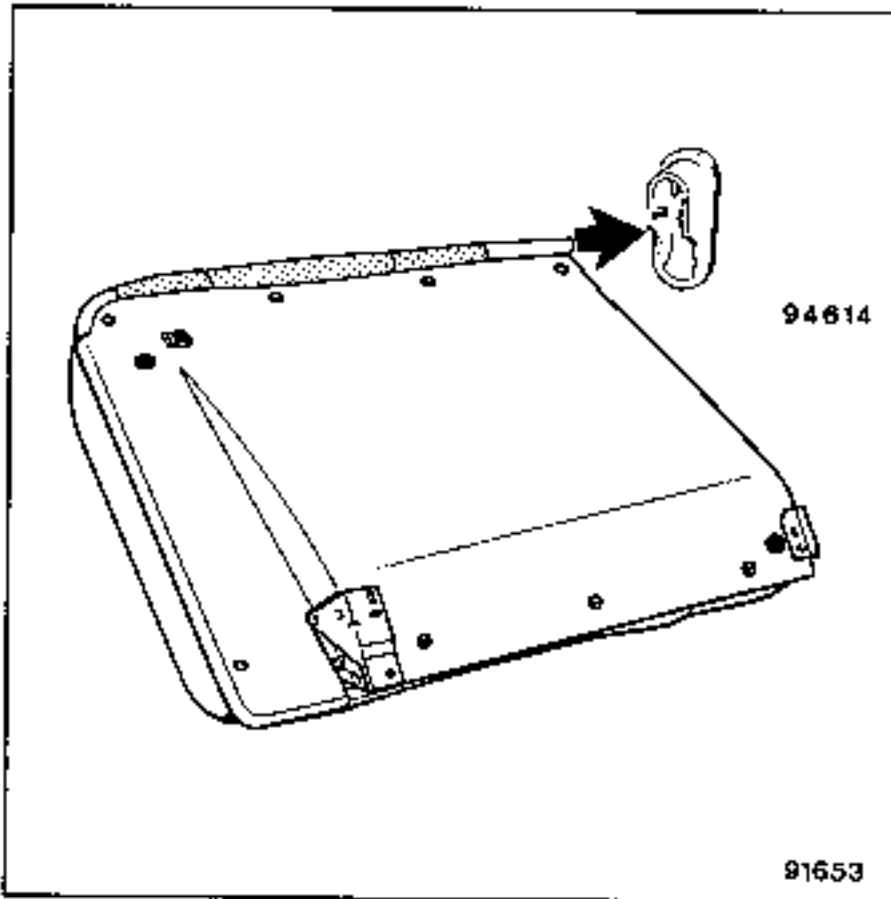
Remove the clips.

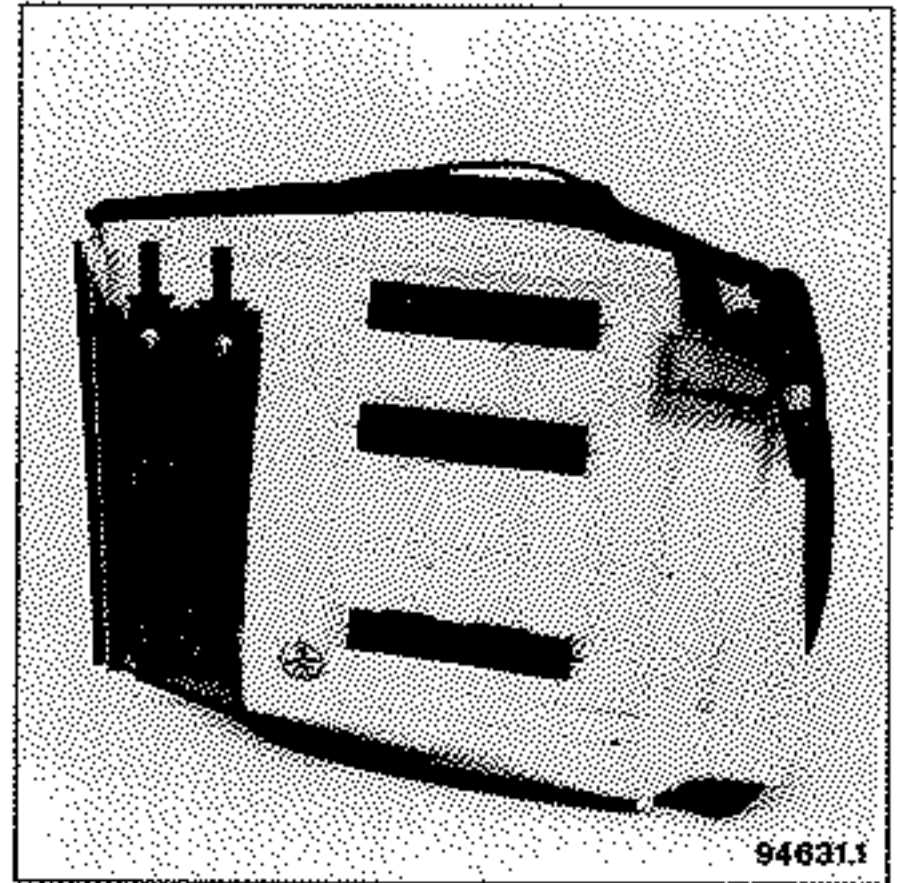
Unclip the 2 clips under the trim.

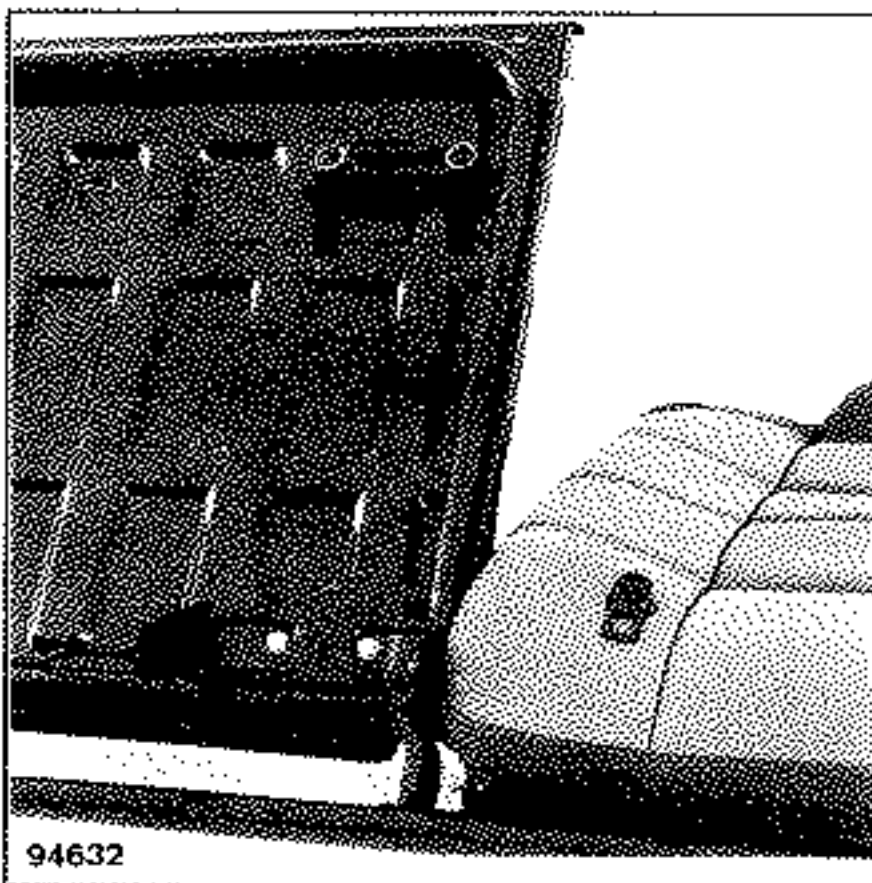
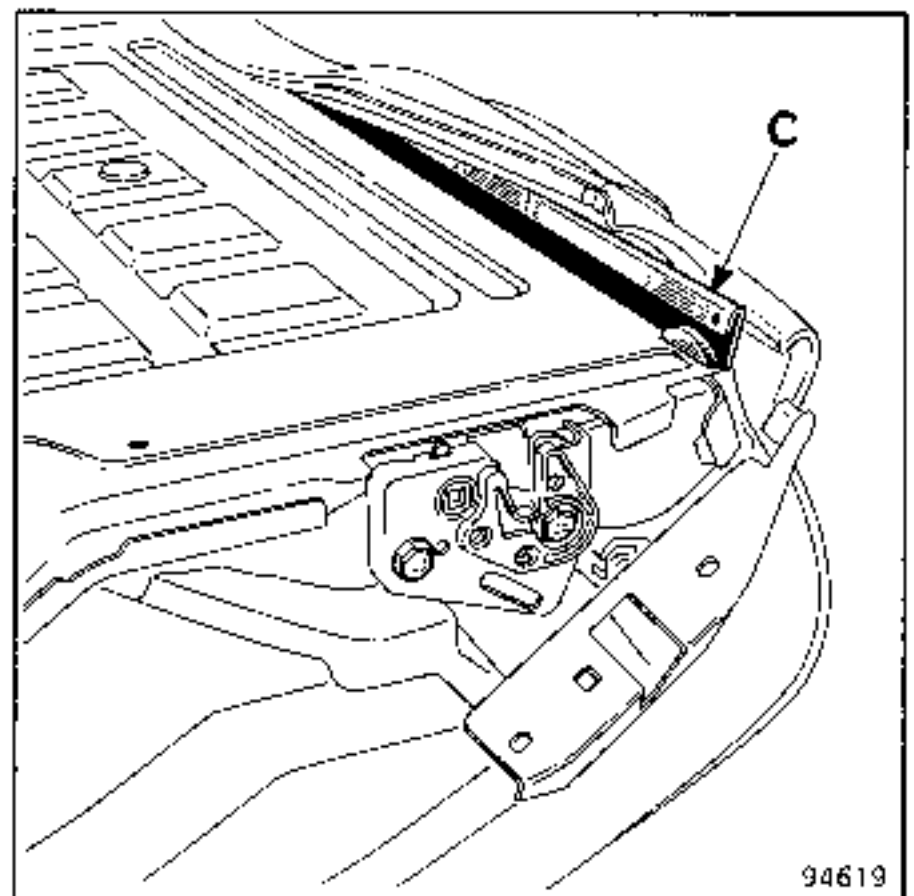
Pass the seat belt through the trim.

Unclip the upper edge (C).

Remove the trim foam assembly.

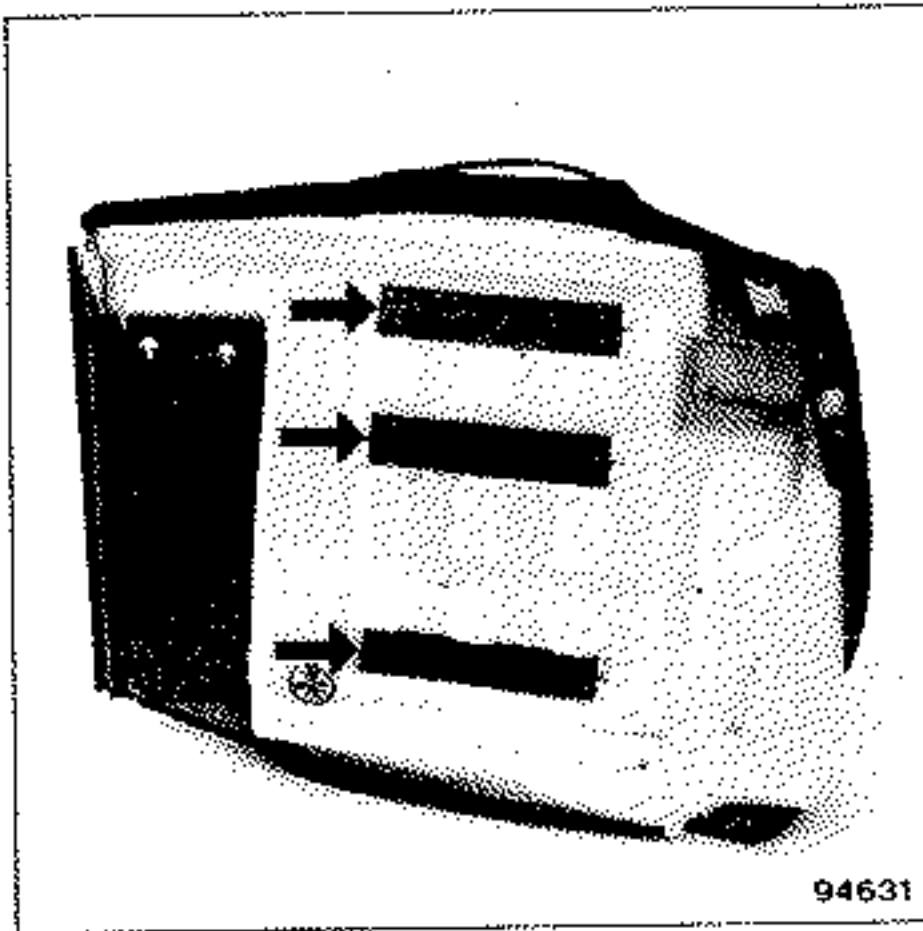
Remove the circular clip.

Separate the trim, passing the card through the foam.

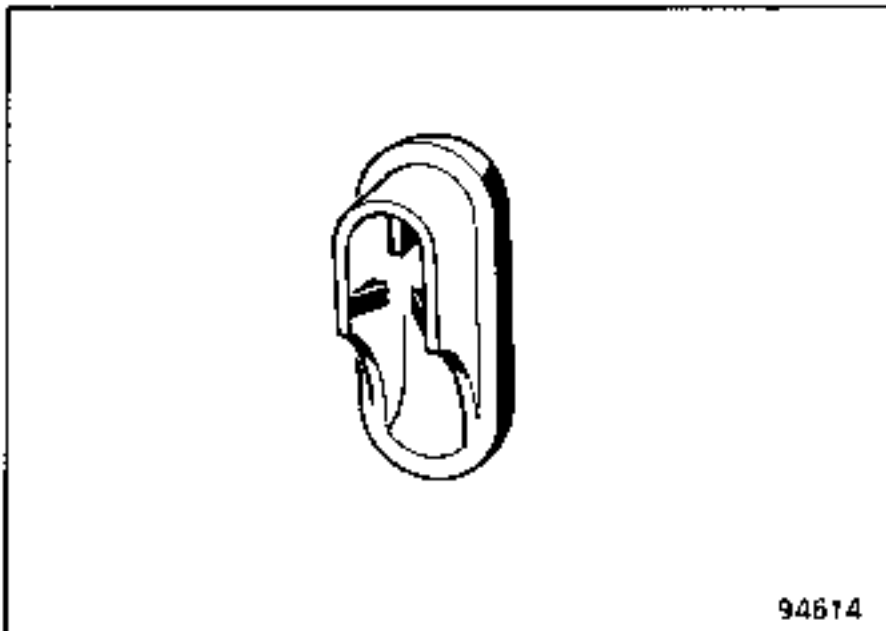
NOTE:

On refitting, refit the end pieces to the frame before positioning the trim.

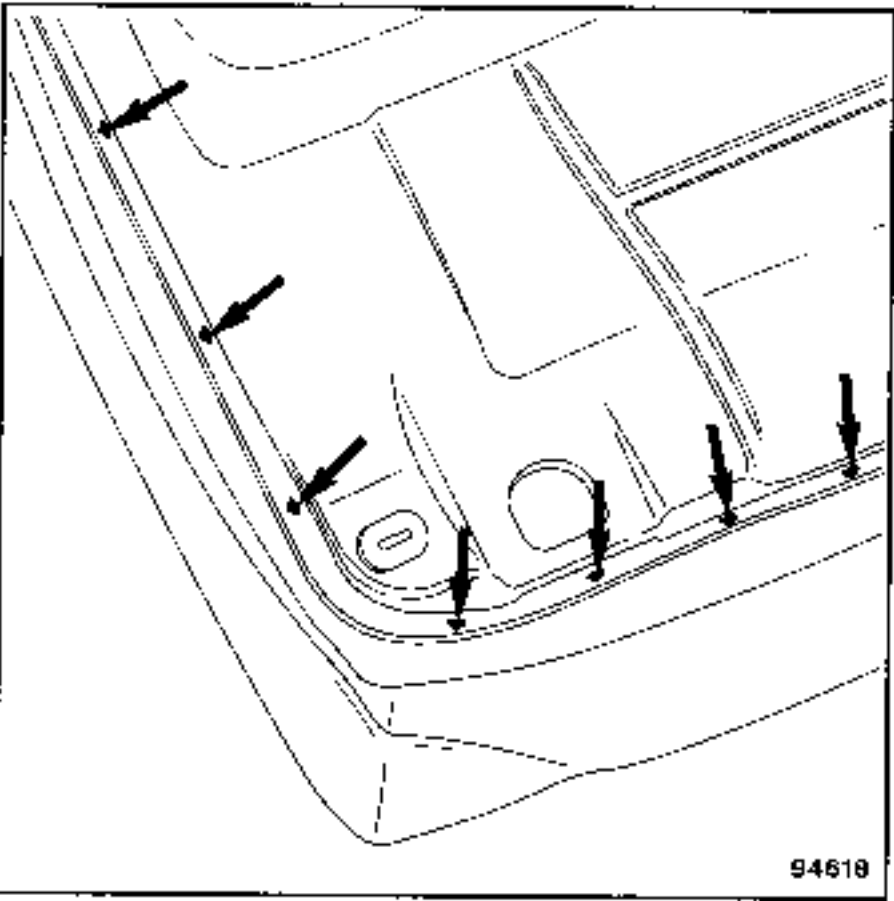
First remove the part in question.
Unclip the trim from the frame with great care.
